## **Custom Home Inspection Report**

### Mr. & Mrs Joesph W. Doe 99 House Lane ~ YourTown New York, 14655

# SiteTech Home Inspections, LLC 585-703-0369

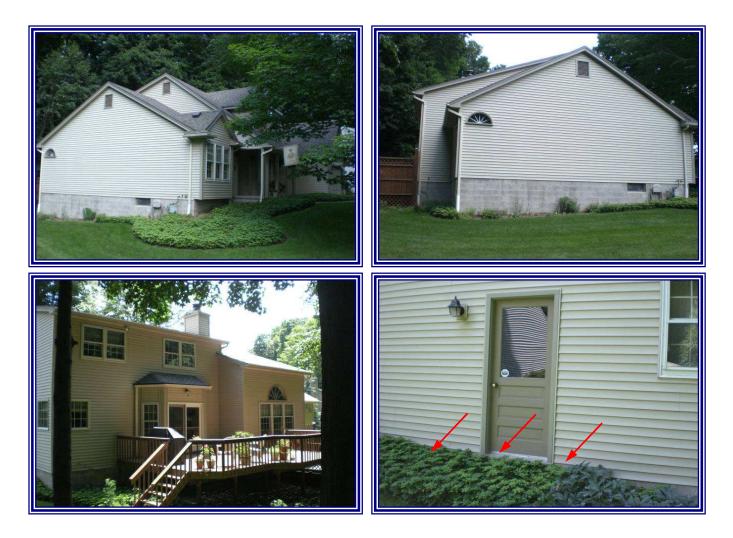
Landscape
#	Condition	Component	Description - Condition - Implication
1	Defective	Steps/Stoops:	Garage man-door is blocked with foliage.
2	Acceptable	Deck:	Pressure treated lumber with 2 levels. Note: supports are in contact with grade which is common, but can shorten life of supports due to excessive moisture contact.
3	Acceptable	Porch:	Concrete - no issues noted, appears to be in proper condition.
4	Marginal	Vegetation:	Blocking doorway, garage man-door and in some cases too close to house.
5	Not Present	Retaining Walls:	
6	Not Present	Outside Stairwell:	
7	Not Present	Window Wells:	
8	Acceptable	Grading:	Grading is properly slopped away from structure.
9	Acceptable	Swales:	Swale front left - No issues noted.
10	Acceptable	Driveway:	Blacktop - estimated 10 years old - very good condition (picture under exterior)
11	Acceptable	Sidewalks:	Concrete - exhibits normal wear.
12	Not Present	Shed:	
13	Not Present	Fencing:

14	Not Present	Pool:	
15	Not Inspected	Outside Hot-Tub	Outside the scope of a normal home inspection. Buyer has indicated that she will remove hot tub.

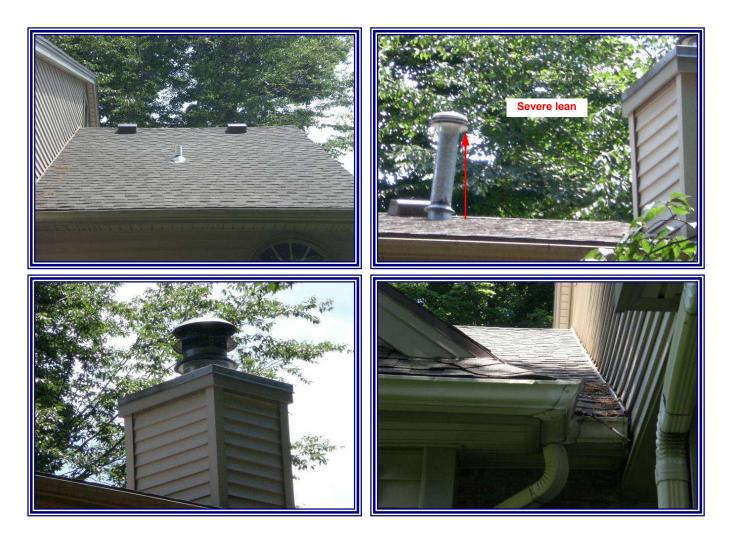
#	Condition	Component	Description - Condition - Implication
1	Not Inspected	Electric Mast:	Underground service entrance.
2	Acceptable	Roof-Line	Appears in proper order. Viewed from road and walked roof.
3	Acceptable	Roof Covering:	Asphalt Shingles - (architectural type) - estimated between 8-10 years of age - Single layer - no issues were found.
4	Marginal	Chimney:	Chimney flue is leaning and could become disconnected over time causing a poor drafting condition. Further investigation by qualified roofing contractor is highly recommended.
5	Acceptable	Plumbing Vents:	Vent - appears functional.
6	Acceptable	Roof Vents:	Box vent type, appears functional.
7	Acceptable	Valleys:	Appears functional.
8	Not Present	Sky Lights:	
9	Acceptable	Flashings:	Appears functional.

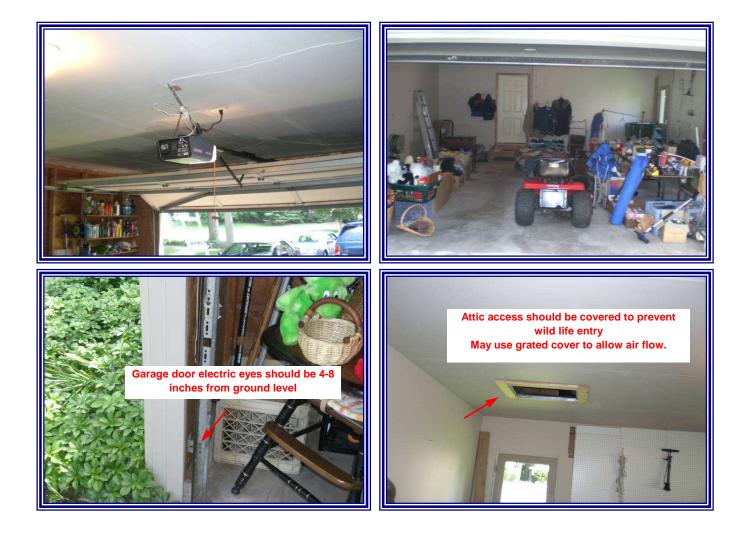
Garage-Carport				
#	Condition	Component	Description - Condition - Implication		
1	Acceptable	Doors/Locks:	Steel house entry door is functionally properly. See man-door access comments under landscape.		
2	Acceptable	Floor:	Poured concrete - floor has some normal cracks.		
3	Acceptable	Walls:	Drywall - no apparent issues.		
4	Acceptable	Lighting:	Ceiling fixture - component is operating properly.		
5	Acceptable	Rafters/Joist:	Covered by drywall - no issues observed here from ceiling access panel.		
6	Not Present	Stairs:			
7	Not Present	Hand Rail:			
9	Acceptable	Outlets:	120 vac outlet (3-prong) - (2) samples checked operational.		
10	Acceptable	Garage Door:	Wooden - unit is functioning properly.		
11	Marginal	Elec.Door Opener:	Note: Electric eye used to stop the garage door in the event of someone or something being under the door while in motion is functioning properly. However, it is noted that the mounting is extremely high. It is highly recommended that this device be mounted approx. 4-8 inches above the floor so that small children or animals block the beam and stop the door when necessary. This is a safety issue and proper mounting is highly recommended.

12	Not Present	Windows & Locks:			
13	Marginal	Attic Access Hatch	Hatch is open and susceptible to wildlife entry. Suggest covering access hatch.

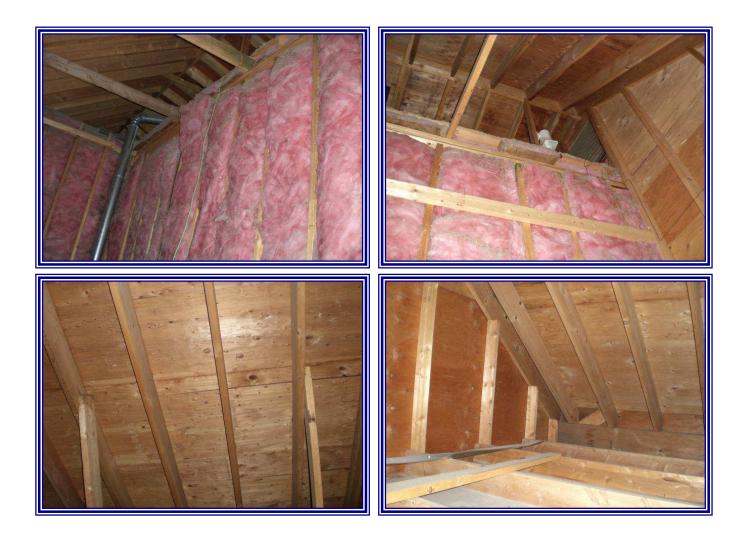
Attics					
#	Condition	Component	Description	- Condition -	Implication	
1	Marginal	Access Hatch:	See garage - access hatch	See garage - access hatch should not be fully open.		
2	Not Present	Lighting:				
3	Acceptable	Trusses:	Joists - no issues observed	I here.		
4	Acceptable	Rafters:	Wood - no issues observed	here.		
5	Acceptable	Insulation:	Combination of fiberglass a	Combination of fiberglass and blown in cellulose Min 6 inches is evident throughout.		
6	Acceptable	Ventilation:	Combination of roof box vents and gable vents Ventilation is sufficient for this space.			
7	Acceptable	Roof Sheathing:	Plywood - component functioning properly at the time of inspection.			
8	Acceptable	Exhaust Flues:	Galvanized steel compor	nent functioning properly at the time	of inspection.	
9	Acceptable	Plumbing Vents:	PVC - unit is functioning pr	operly.		
10	Not Present	Doors & Locks:				
11	Not Present	Walls:

12	Not Present	Ceiling:				
13	Not Present	Floor:	Floor:			
14	Not Present	Windows & Locks:				
15	Not Present	Outlets:				
16	Not Present	Stairways

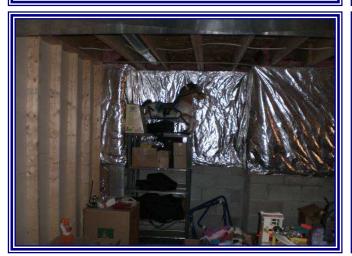
Basement				
#	Condition	Component	Description - Condition - Implication		
1	Not Present	Doors & Locks:			
2	Acceptable	Walls:	Some drywall - no apparent issues.		
3	Acceptable	Ceiling:	joist - no issues observed.		
4	Acceptable	Floor:	Poured concrete - no observed issues.		
5	Acceptable	Heat Source:	Vent - this item is operational.		
6	Acceptable	Windows & Locks:	awning wooden - appear proper - not opened.		
7	Acceptable	Outlets:	120 vac outlet (3-prong) - (3) samples checked operational. (see electrical wiring below)		
8	Acceptable	Lighting:	Ceiling fixtures - component is operating properly.		
9	Acceptable	Main Supt. Beam:	Steel - component is operating properly.		
10	Acceptable	Support Poles:	Steel tubular - component is operating properly.		
11	Acceptable	Ceiling Joists:	Wooden - no observed issues -		
12	Defective	Electrical Wires:	Copper branch wire for the most part is proper. However, permanent transformer is powered by loose plug on extension cord. Repair by qualified electrician is recommended.

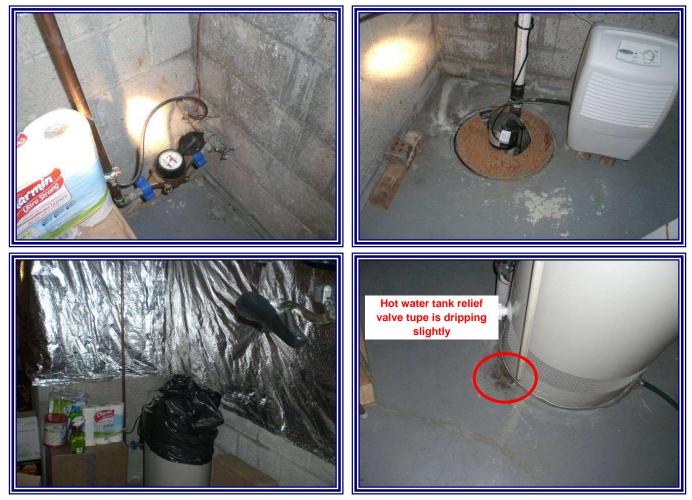
#	Condition	Component	Description - Condition - Implication
1	Acceptable	Pipe Before Meter:	1-inch copper - component functioning properly at the time of inspection.
2	Acceptable	Pipe After Meter:	1-inch copper - component functioning properly at the time of inspection.
3	Acceptable	Main Shut Off:	1-inch copper - component functioning properly at the time of inspection.
4	Acceptable	Pipe Type(s):	1/2-inch copper - component functioning properly at the time of inspection.
5	Acceptable	Water Heater Type:	Natural gas - component functioning properly at the time of inspection.
6	Acceptable	Water Heater Model:	General Electric - Model: Smartwater.
7	Defective	Heater Overflow:	Leaking slightly - Further investigation by licensed plumber is recommended.
8	Acceptable	Water Heater Vent:	Galvanized steel - component functioning properly at the time of inspection.
9	Acceptable	Heater Serviced:	Jun-04
10	Acceptable	Water Heater Age:	Water heater is less than 5 yrs. Old.
