***So... What kind of things does a
Home Inspector discover
anyway...?***

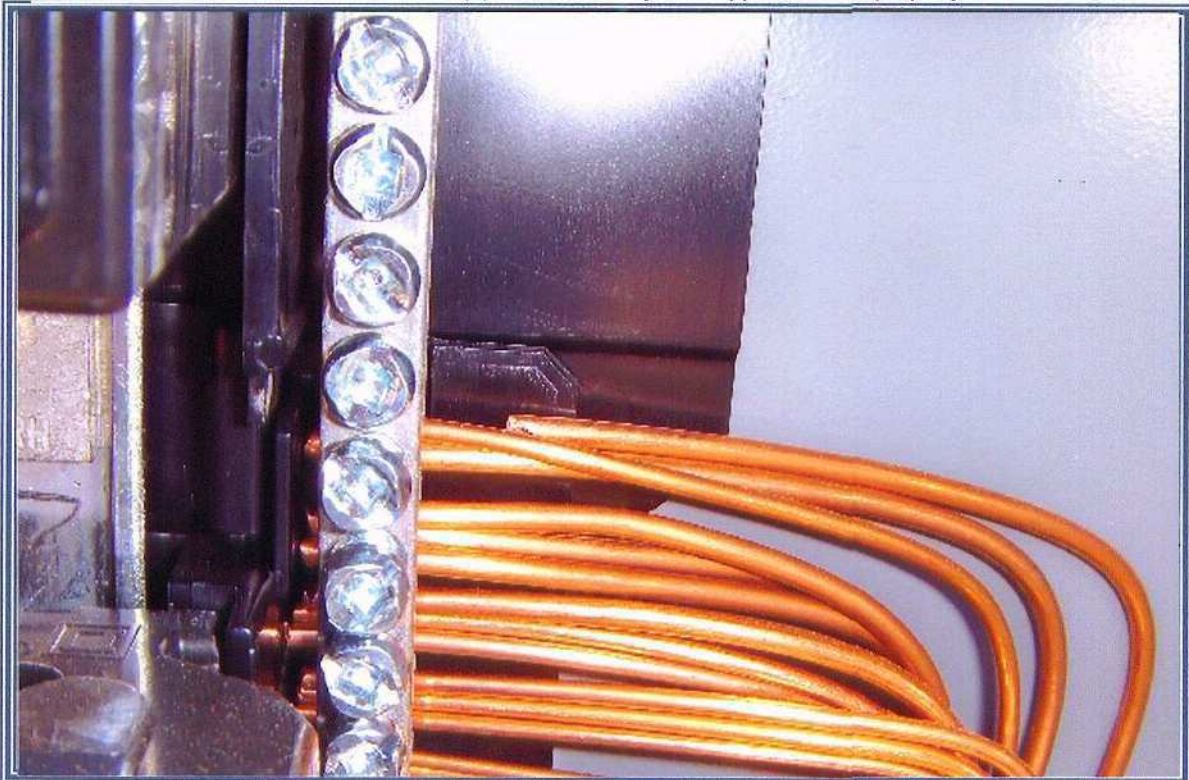
Main Distribution Box:

' Ground wires are there for added safety/protection. They are supposed to be properly attached.

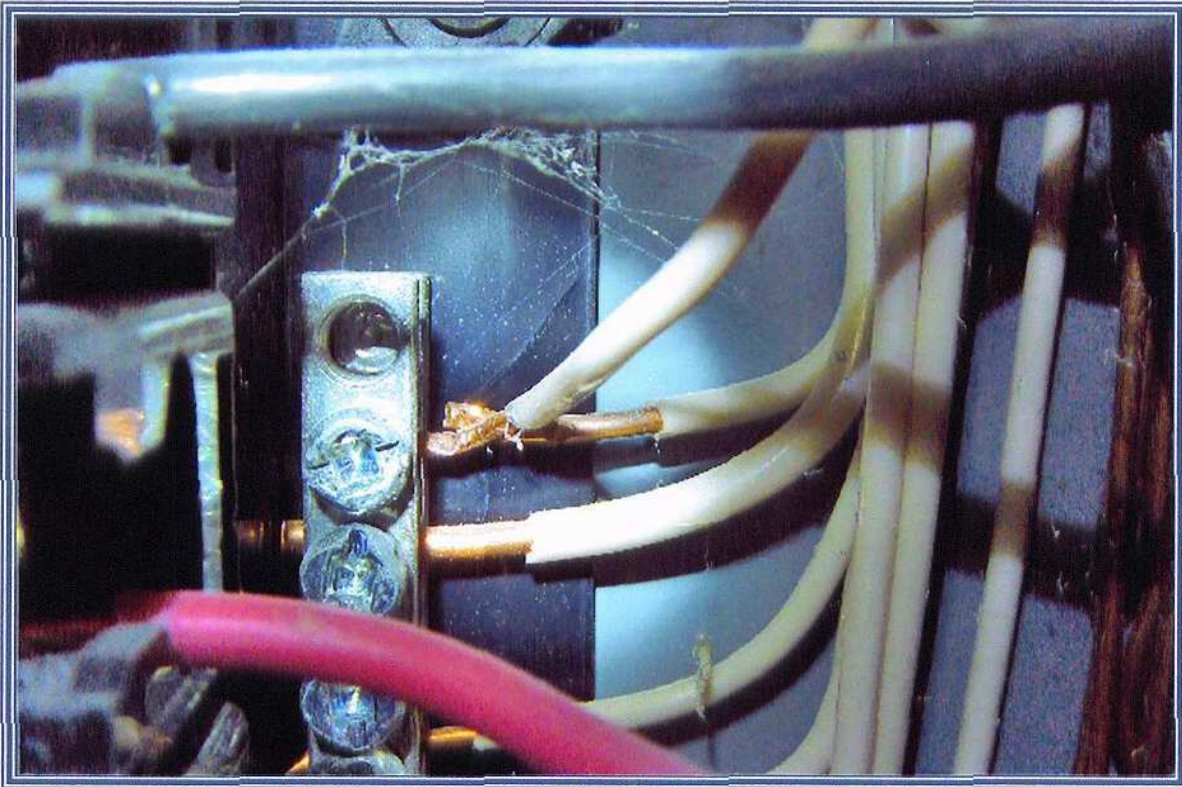
Main Electrical Distribution Box:

- * A circuit must have both a black (hot) and White (neutral) wire in order to work properly. Improperly secured black or white wires can cause sparks and potentially cause a fire.

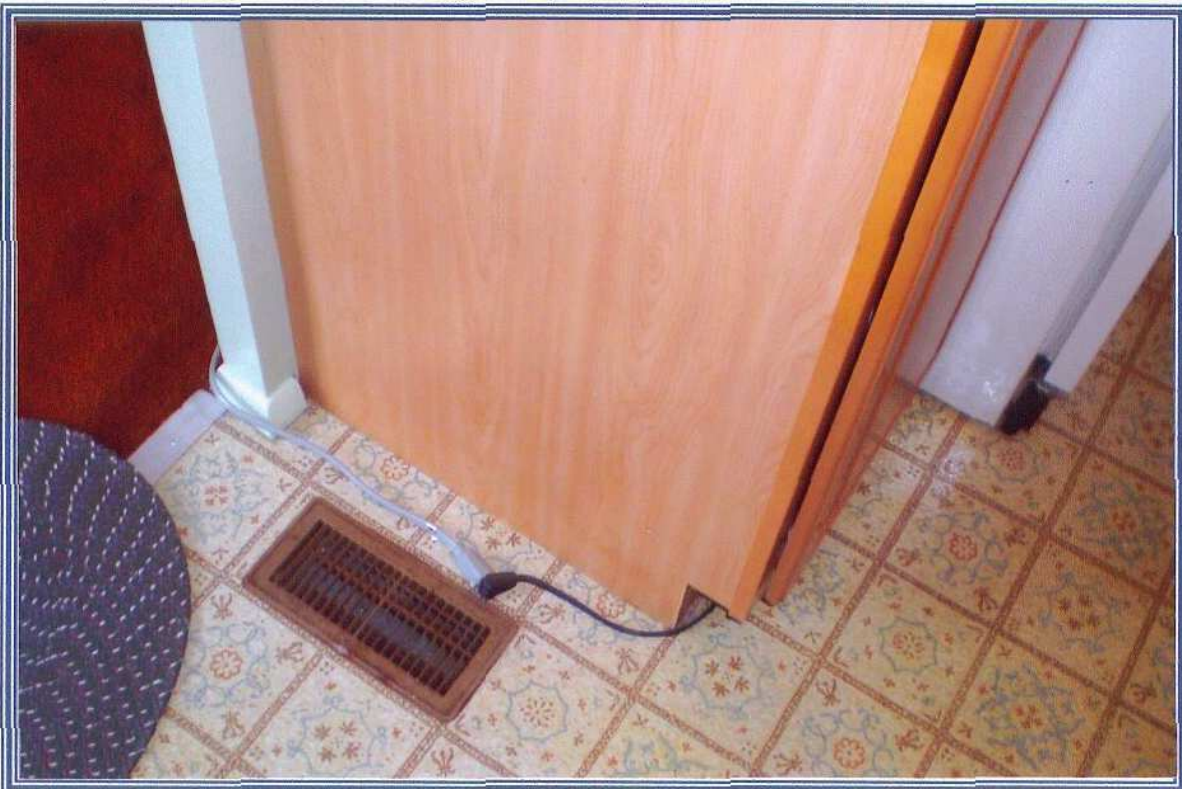
Electrical Branch Wiring:

- * Major appliances are not permitted to be on extension cords (temporary wiring). There is obviously a problem that needs further investigation by a qualified electrician.

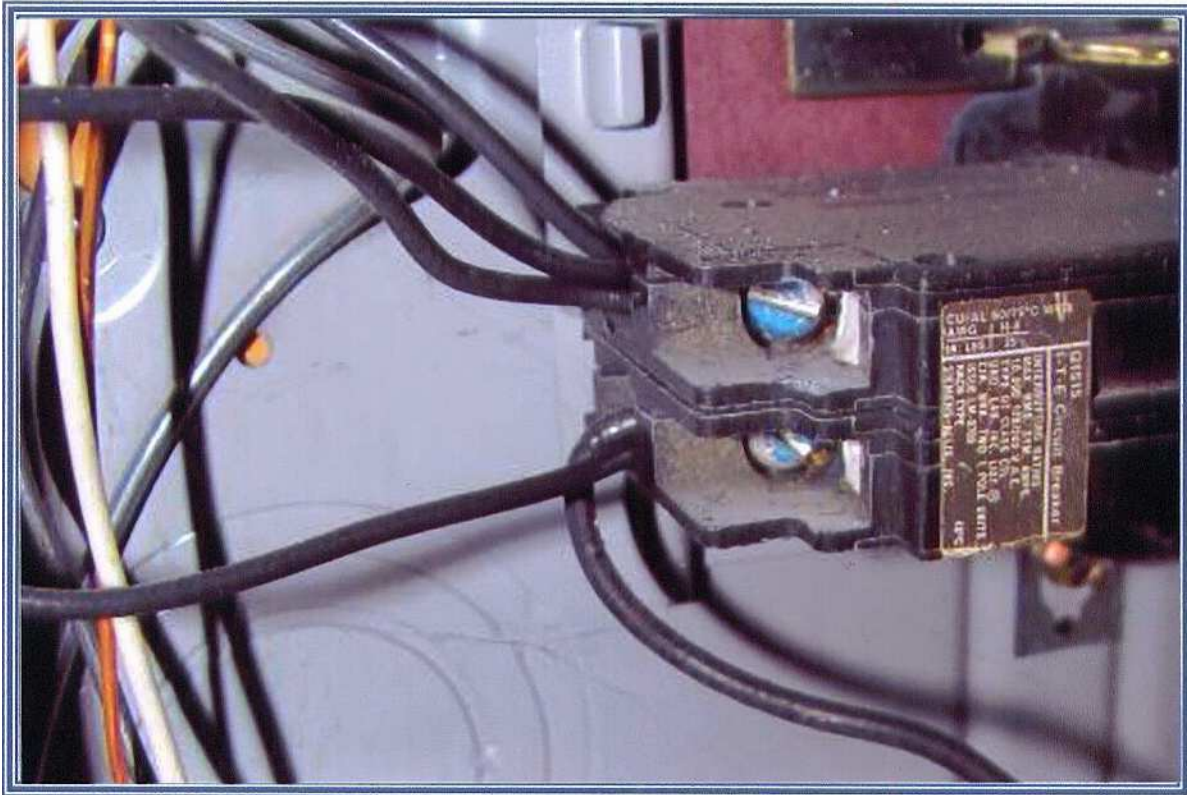
Main Electrical Distribution:

- * There is some controversy over the use of electrical breaker double taps - While two may be company, there is no doubt that three's a crowd, not to mention a safety hazard.

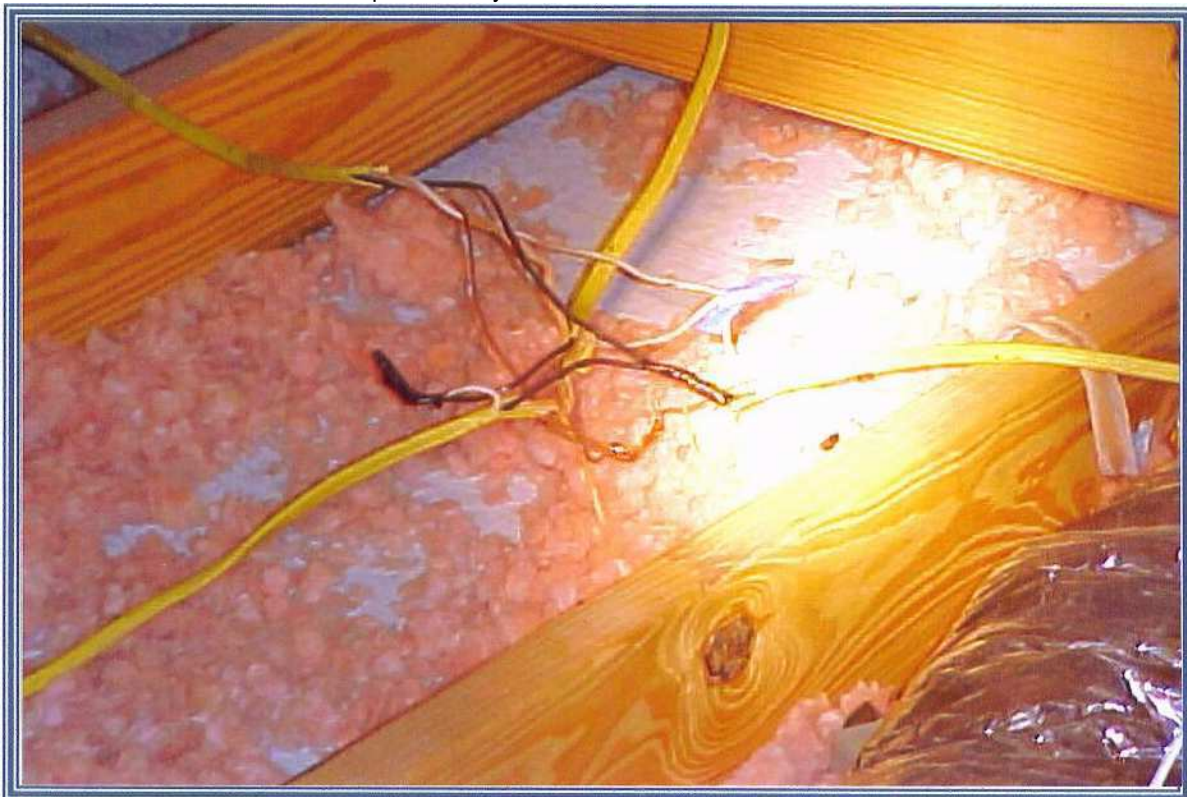
Electrical Branch Wiring:

- * Those darn electrical boxes are so expensive. The good news is there is very little insulation to catch fire should this electrical connection spark one day.

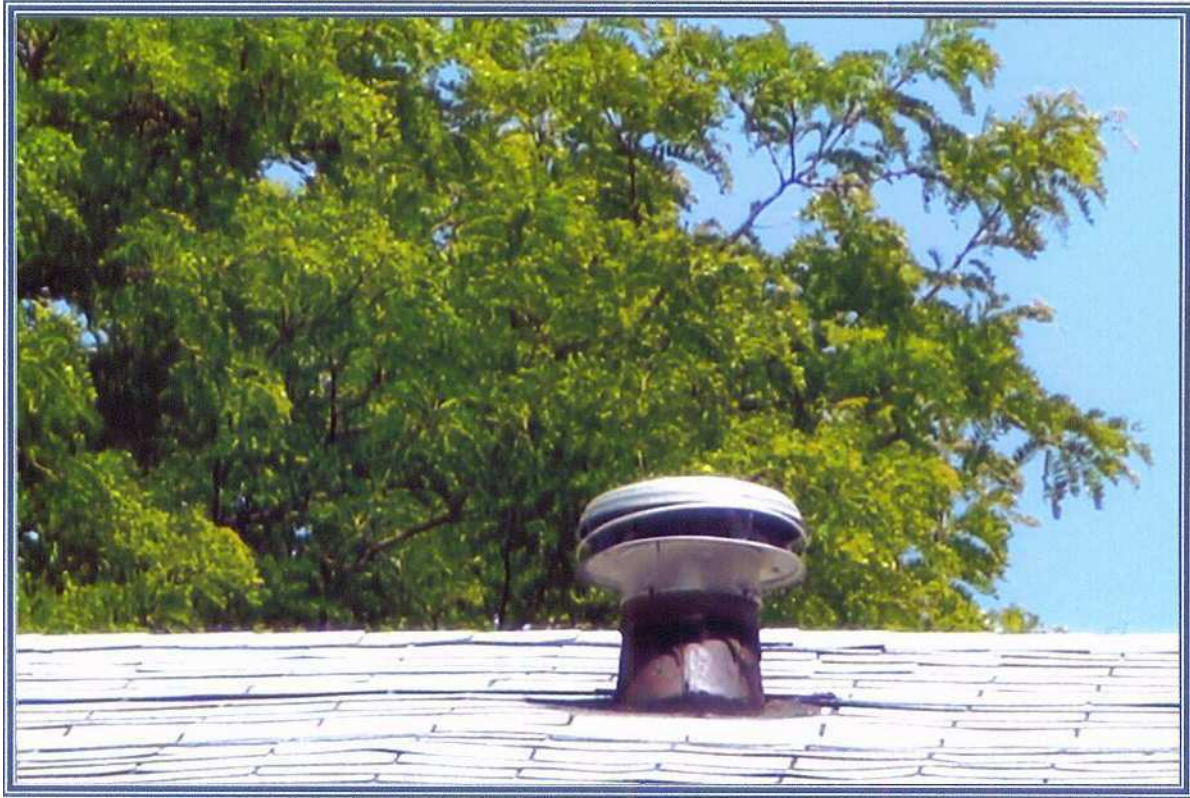
Roof Area:

* Dried out and curling tiles are a sign of an aging asphalt roof. Newer asphalt tiles typically lay flat when everything below them is in good shape. These tiles are fairly new and should not look like this.

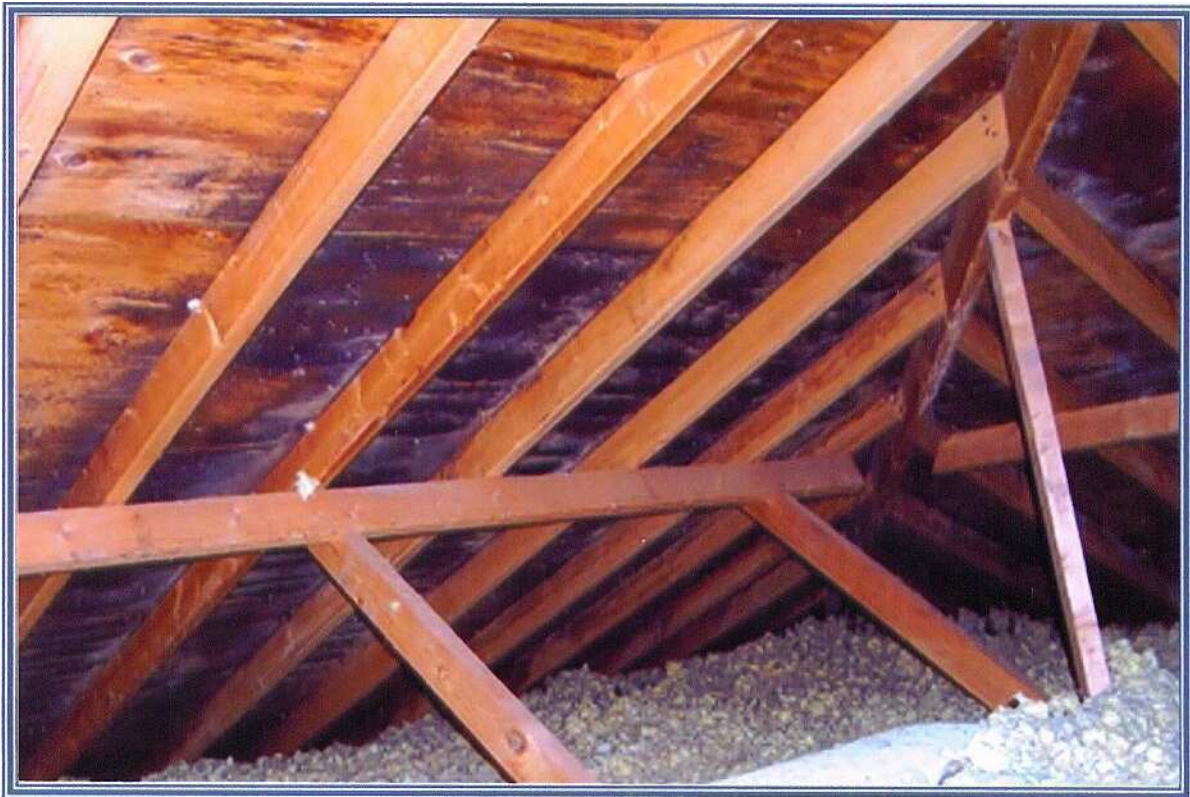
Roof Area:

* Poor ventilation in an attic will cause moisture to collect in the attic, causing the roof decking to delaminate and become soft. Mold can become an issue over time.

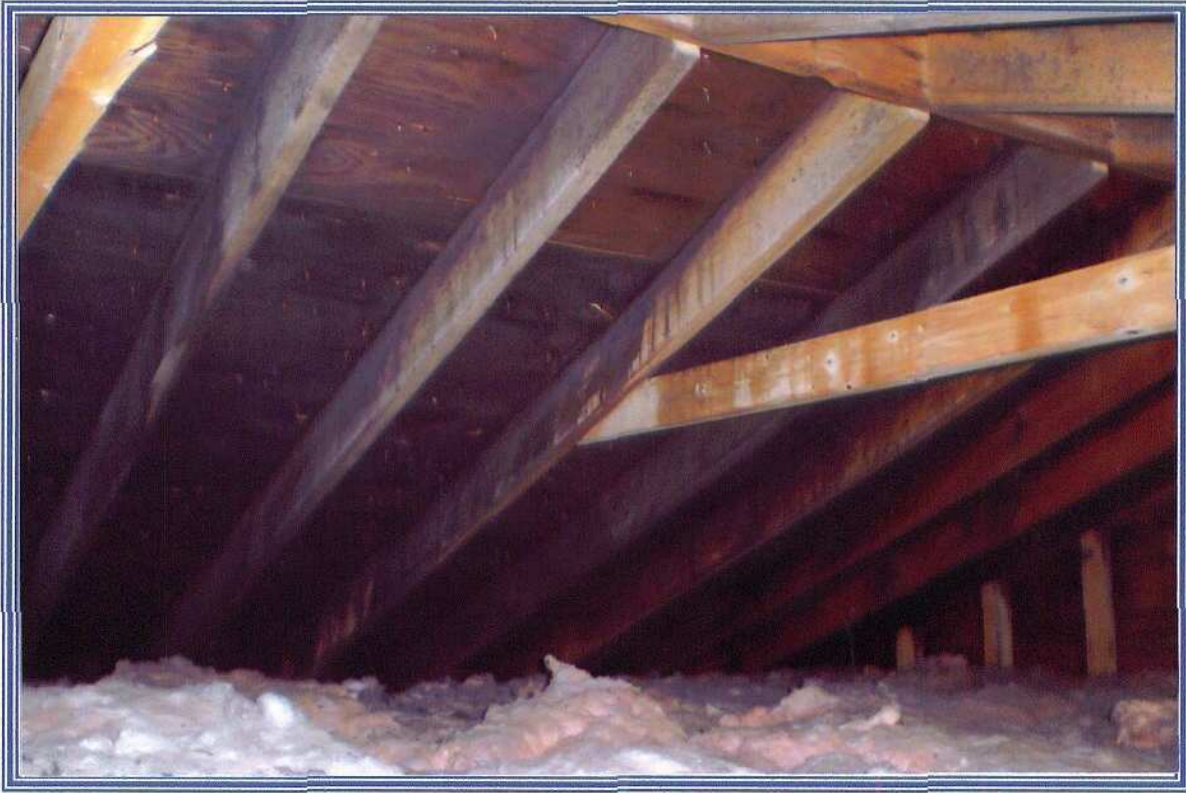
Roof Area:

* As time goes on - a lack of proper ventilation can literally destroy the entire roofing system, costing thousands of dollars to repair. Once moisture and water start entering the structure, things go from bad to worst. On top of the destruction of the home, this condition, if left unresolved, can cause health issues for someone down the line.

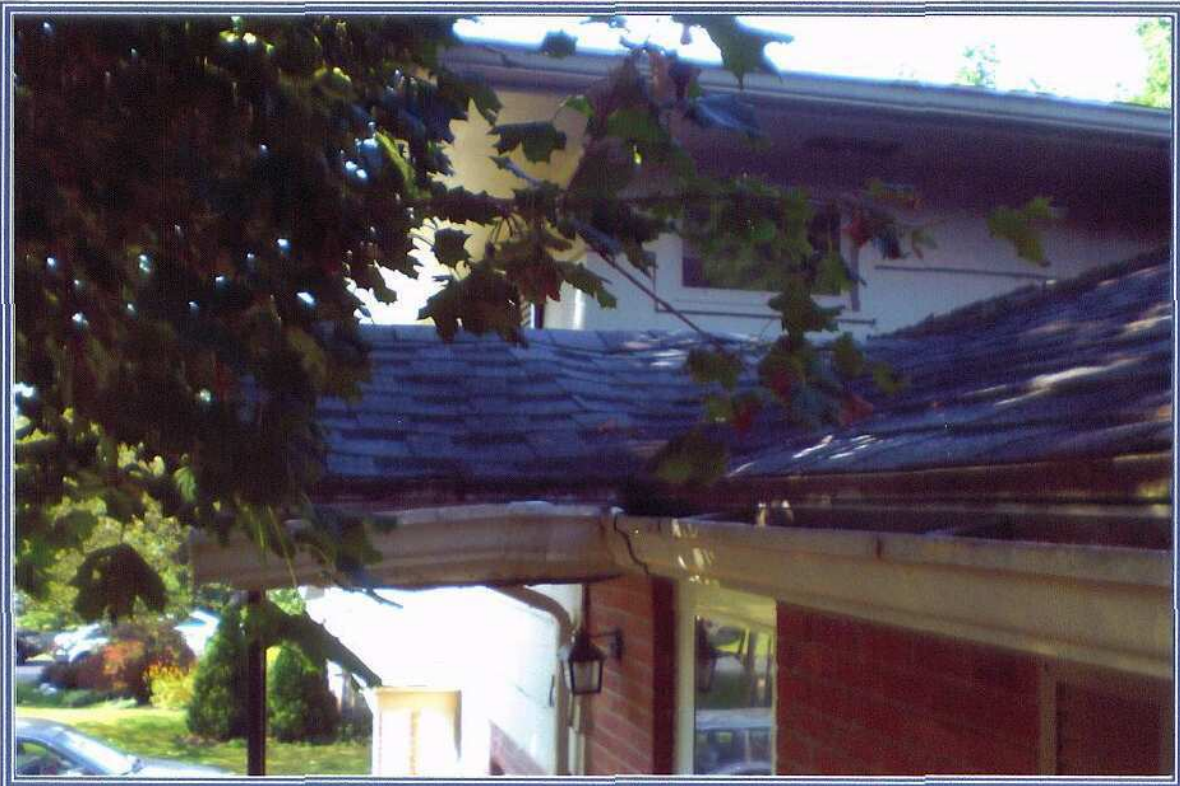
Roof Area:

* A Lack of proper ventilation has caused this roofing system to be totally compromised.

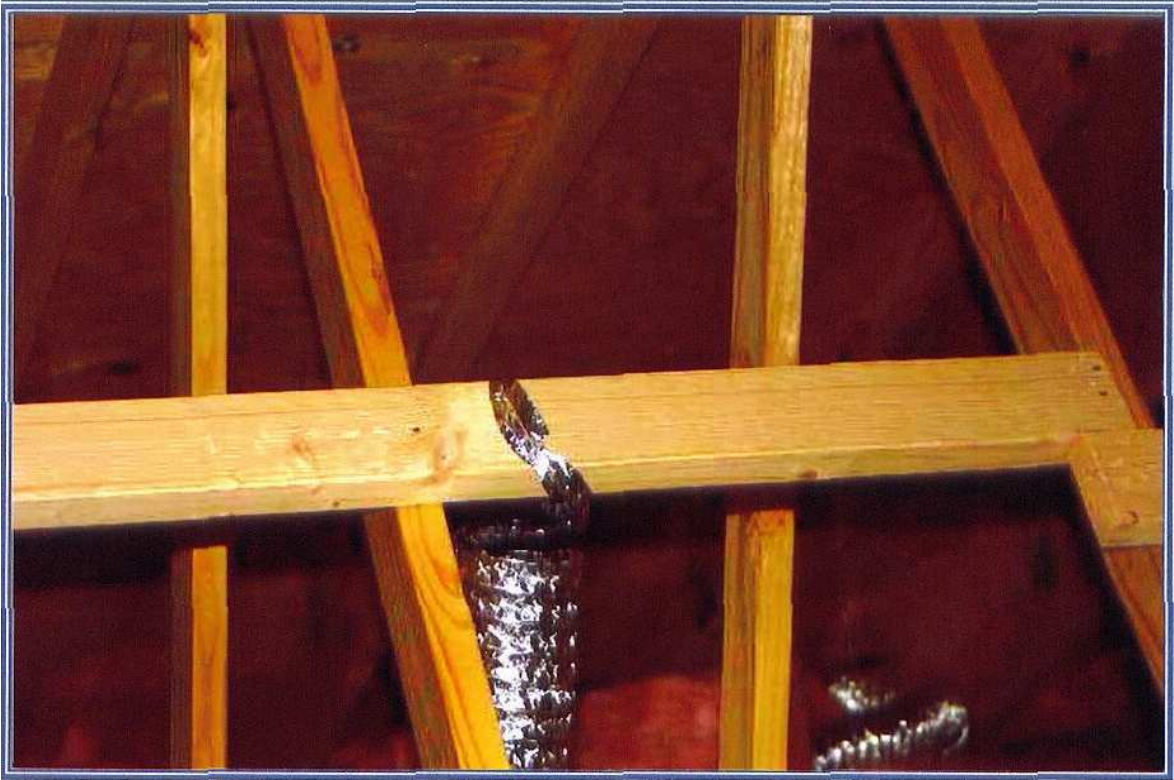
Attic Area:

- * Venting the bathroom fan directly into the attic can cause a tremendous amount of moisture to collect on the roof deck, supports and insulation.

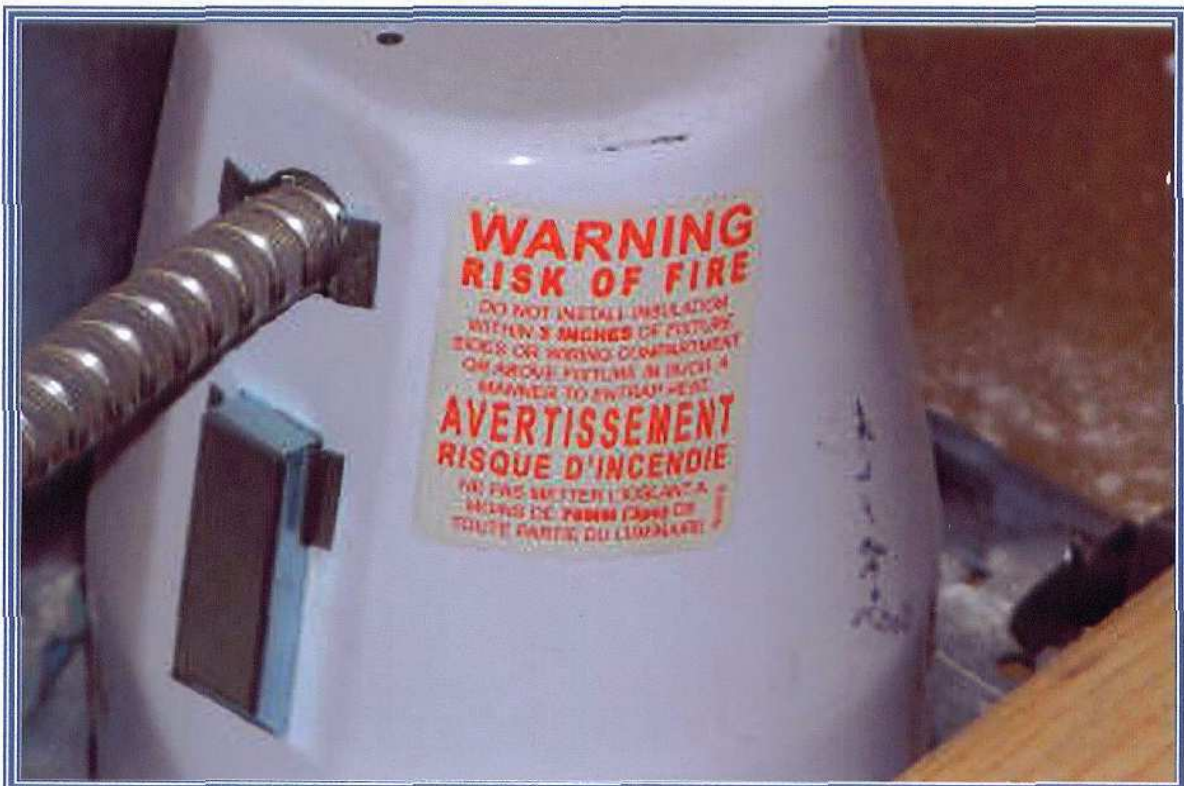
Attic Area:

- * Recessed light fixtures come in (2) types, 1C and Non-IC, When ever the fixture could come into contact with insulation an 1C type fixture should be utilized to prevent fire. This Non-IC can is in an attic.

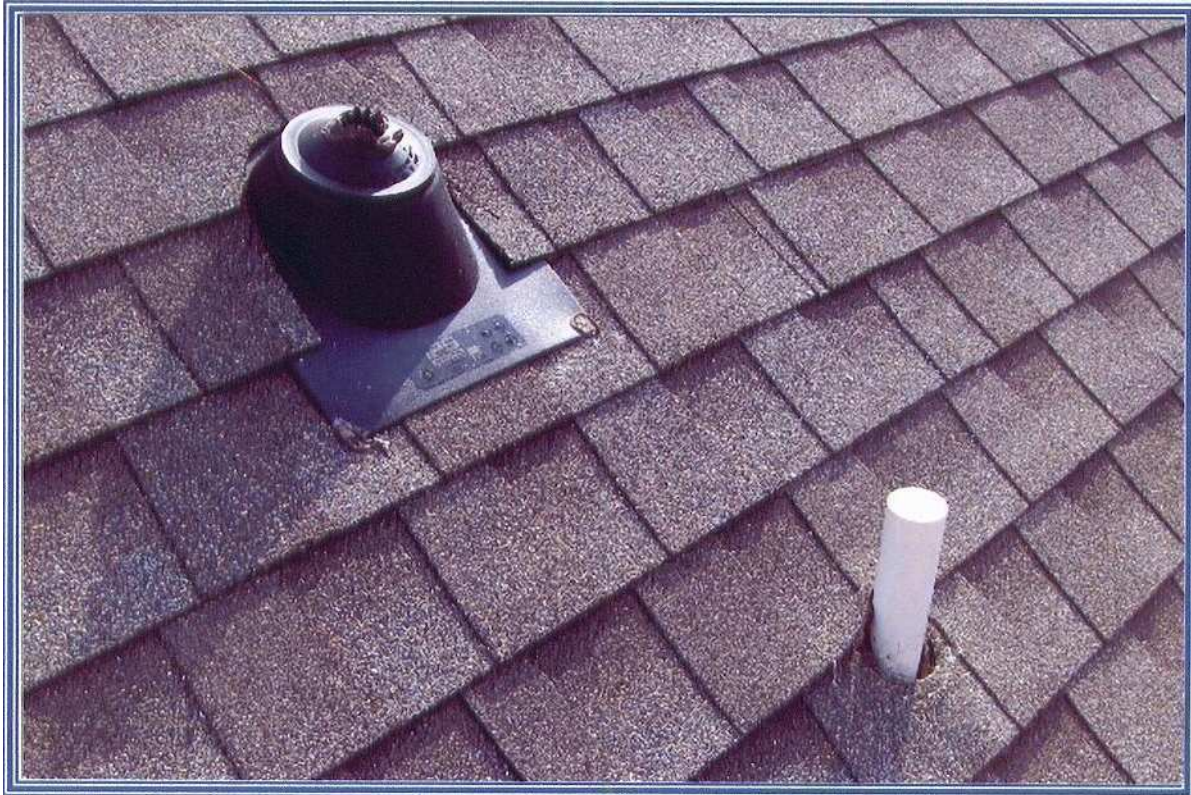
Roof Area:

* There's a lot going on above our heads that can cause expensive repairs if we don't pay attention, in this case a plumbing stack vent was moved during a home improvement project and someone forgot to call the roofer back to remove the old vent and seal up the new vent, so this brand new roof was leaking.

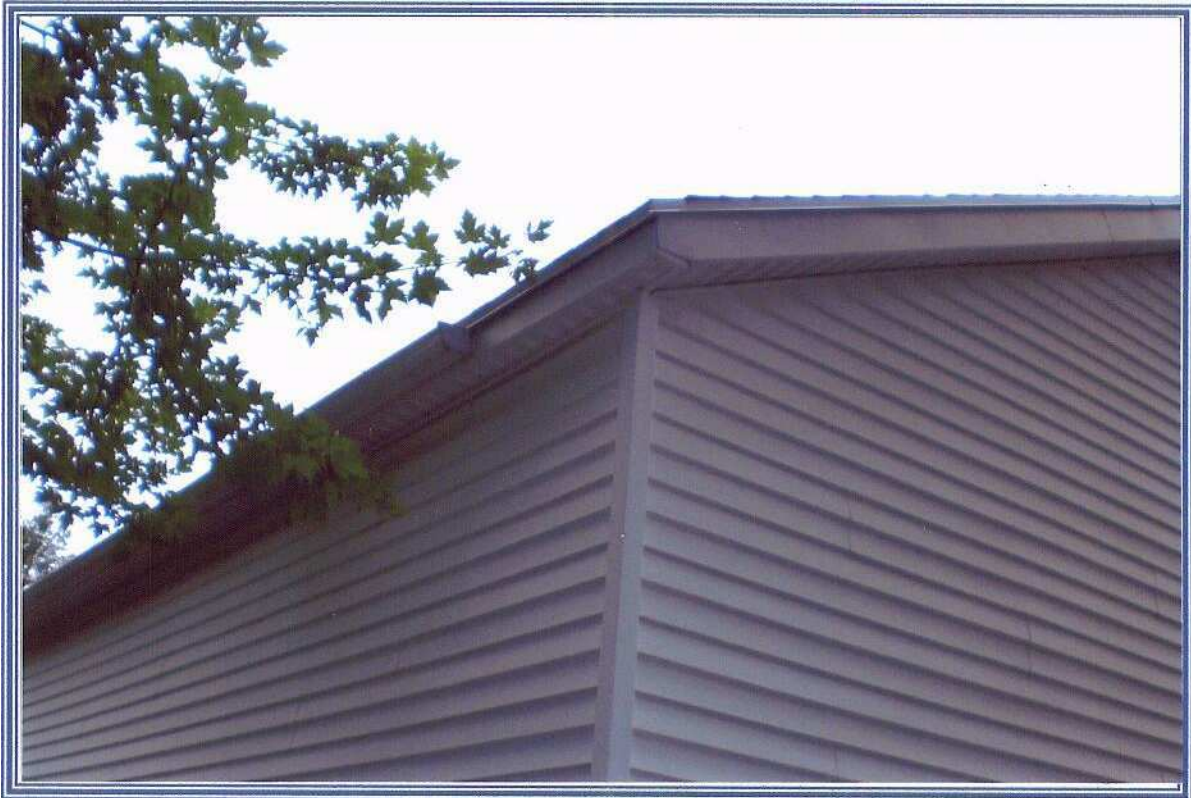
Roof Area:

* Of course the new gutters were working just fine. Watch out for that 25% discount.

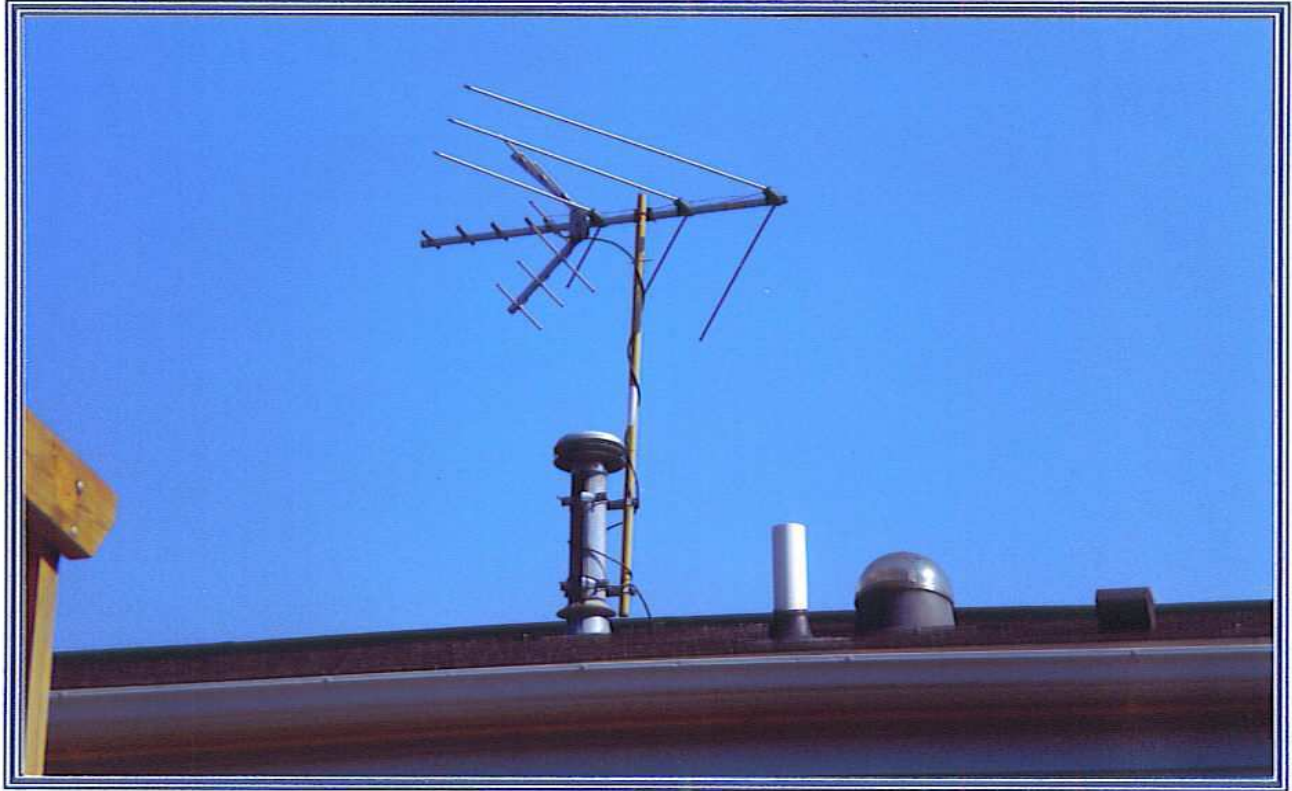
Roofing Area:

- * It is never a good idea to use plumbing stacks, chimneys or other vents to attach items to. The antenna below looks professionally mounted. Unfortunately, most galvanized metal chimney flues are only secured with a few small metal screws. If the wind decides to knock this over, not only will the television reception be poor, but so will the venting of hazardous gases from the furnace below.

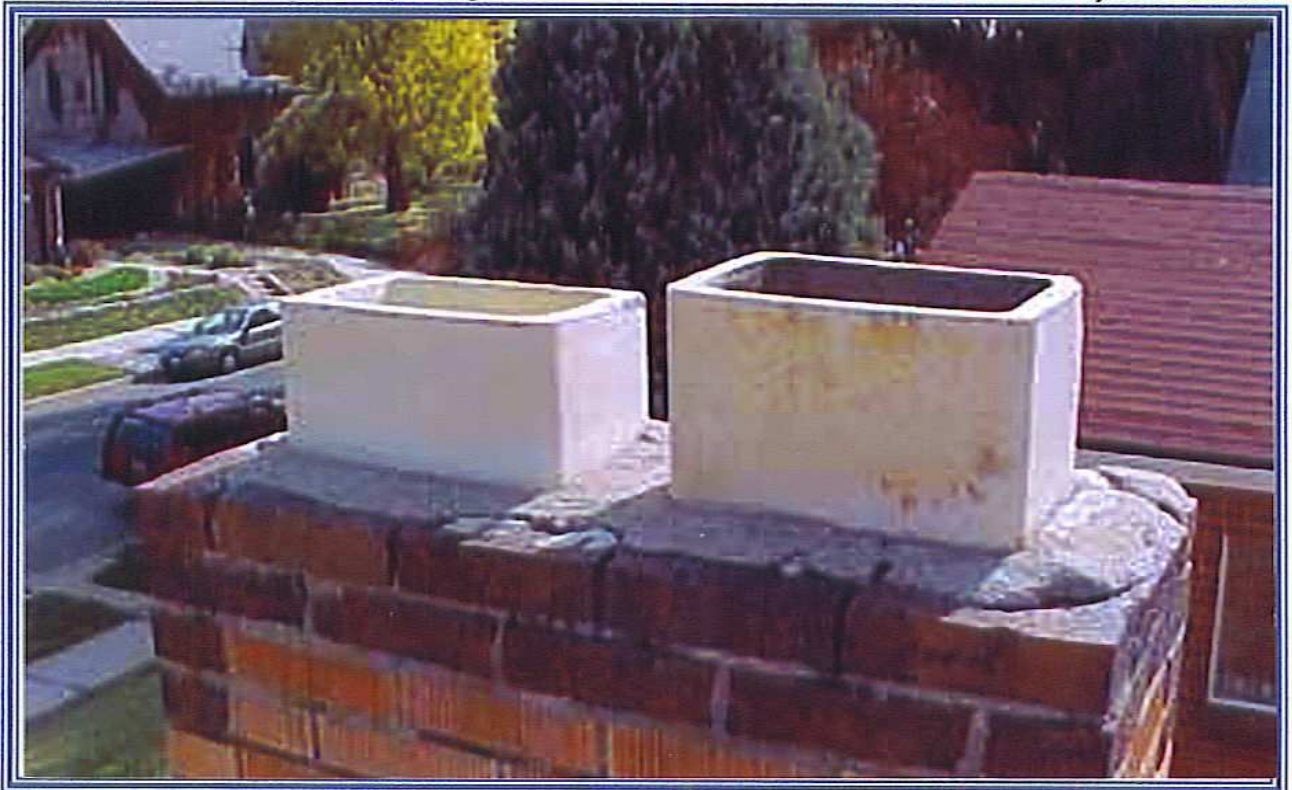
Roof Area:

- * Not only could this chimney use a couple of caps to keep the critters out, but some relatively inexpensive repair on the mortar and repointing of the brick could save this homeowner a lot of money down the line.

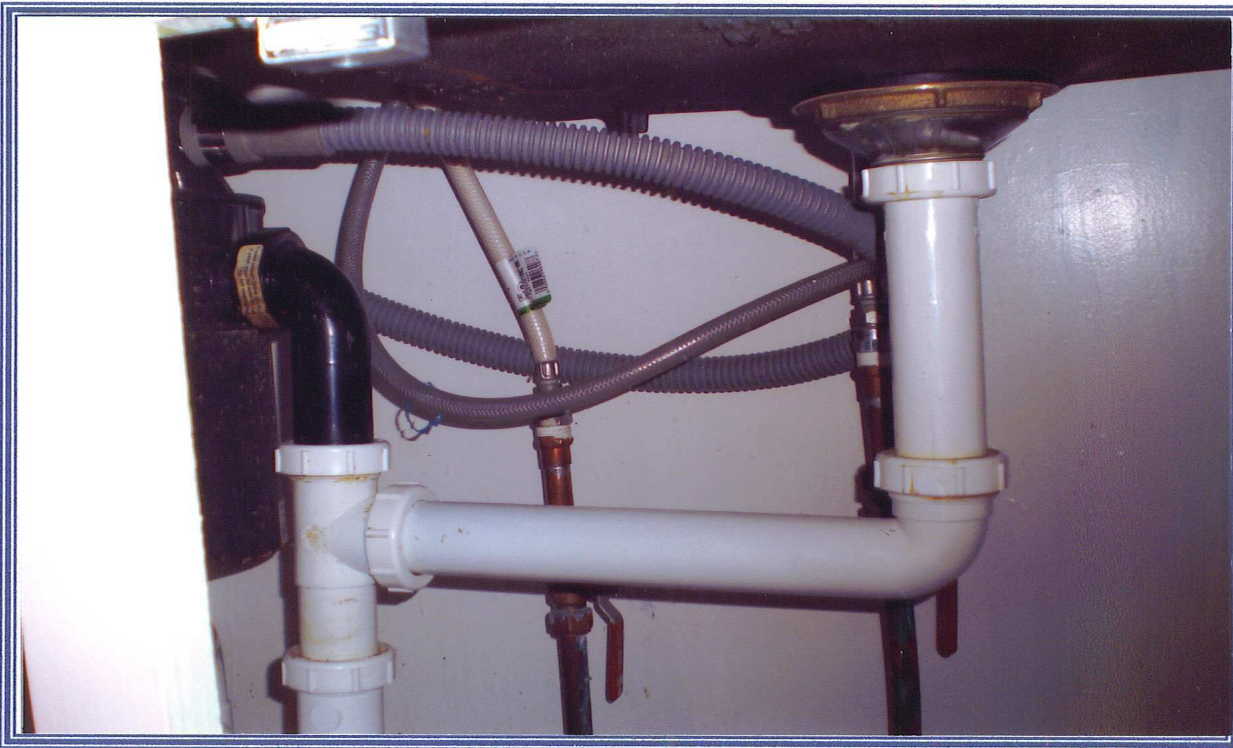
Main Plumbing:

* This drain may look fine to some, but I'm pretty sure that the P-Trap that is missing is used to keep dangerous gases from entering the home through sewage pipes.

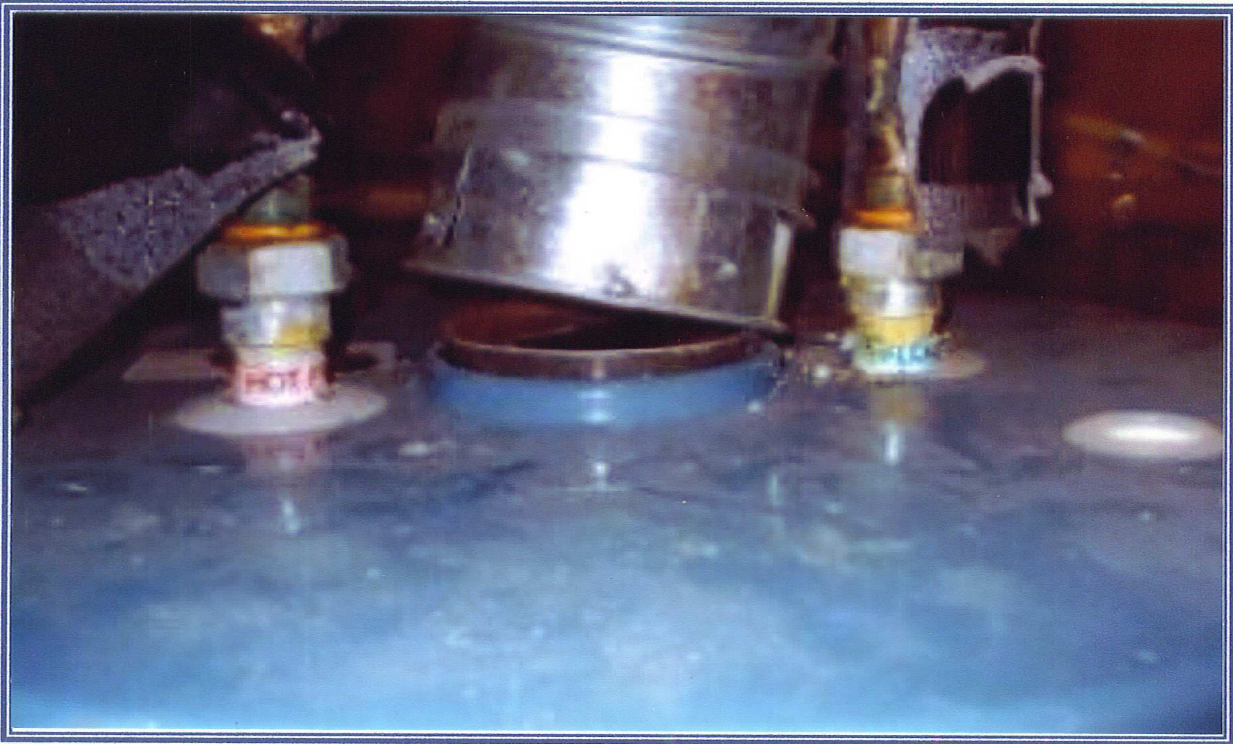
Main Plumbing:

* Speaking of dangerous gases – looks like the top of this hot water tank would be a great place for a CO₂ detector.

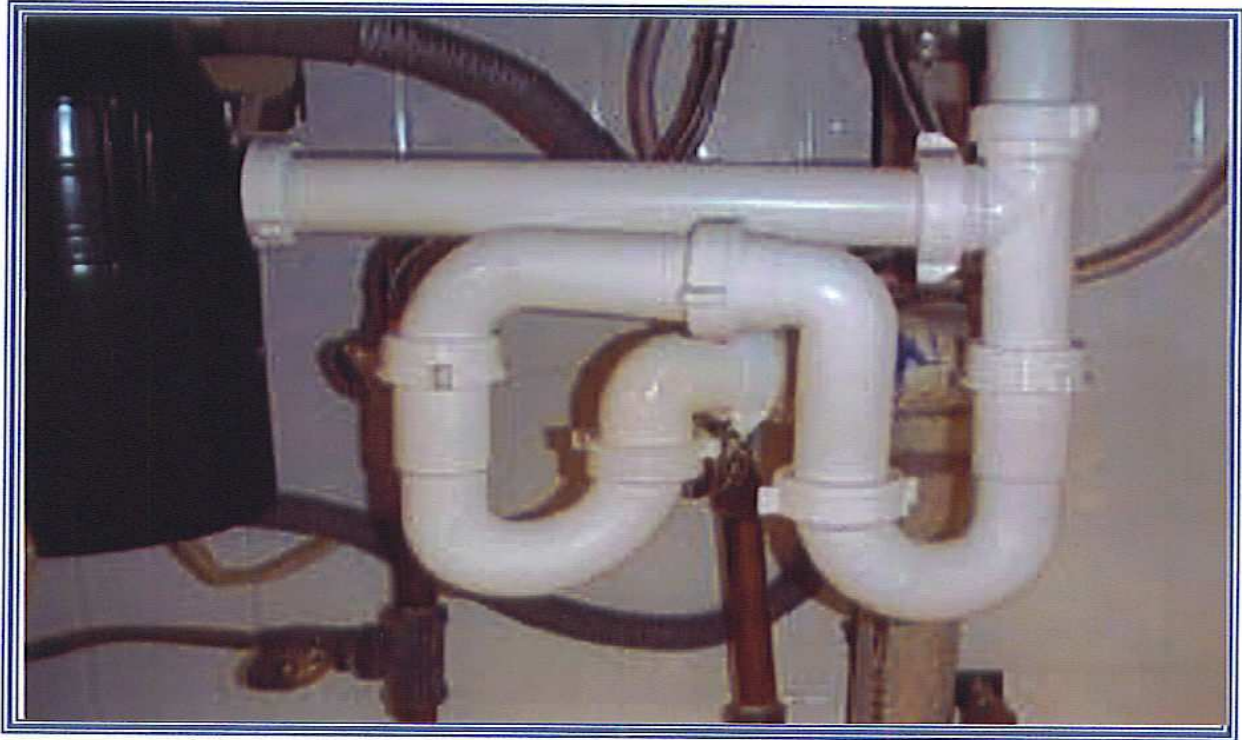
Main Plumbing:

- * Okay – well this would be one to many P-Traps which can actually lead to siphoning in the draining system.

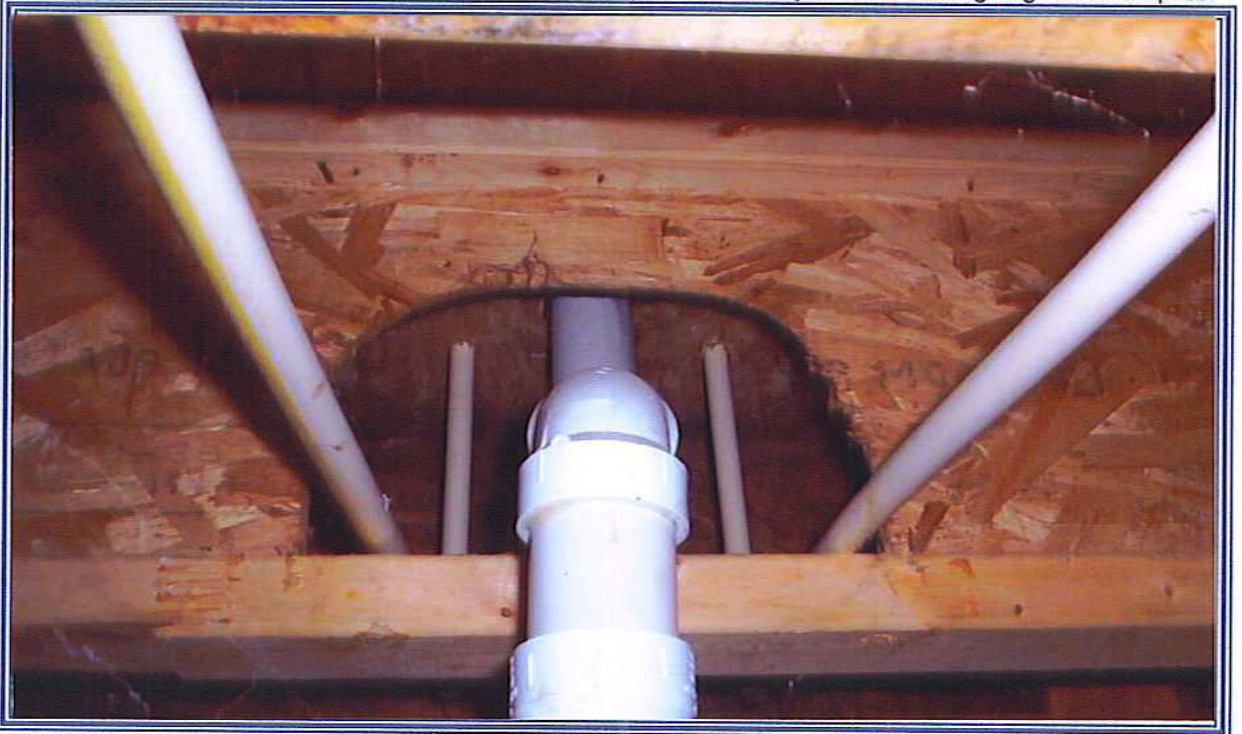
Main Plumbing:

- * There's actually nothing wrong with this plumbing. Now the plumber is another matter. This engineered floor joist has been severely compromised and you can already see it is starting to give at the splice.

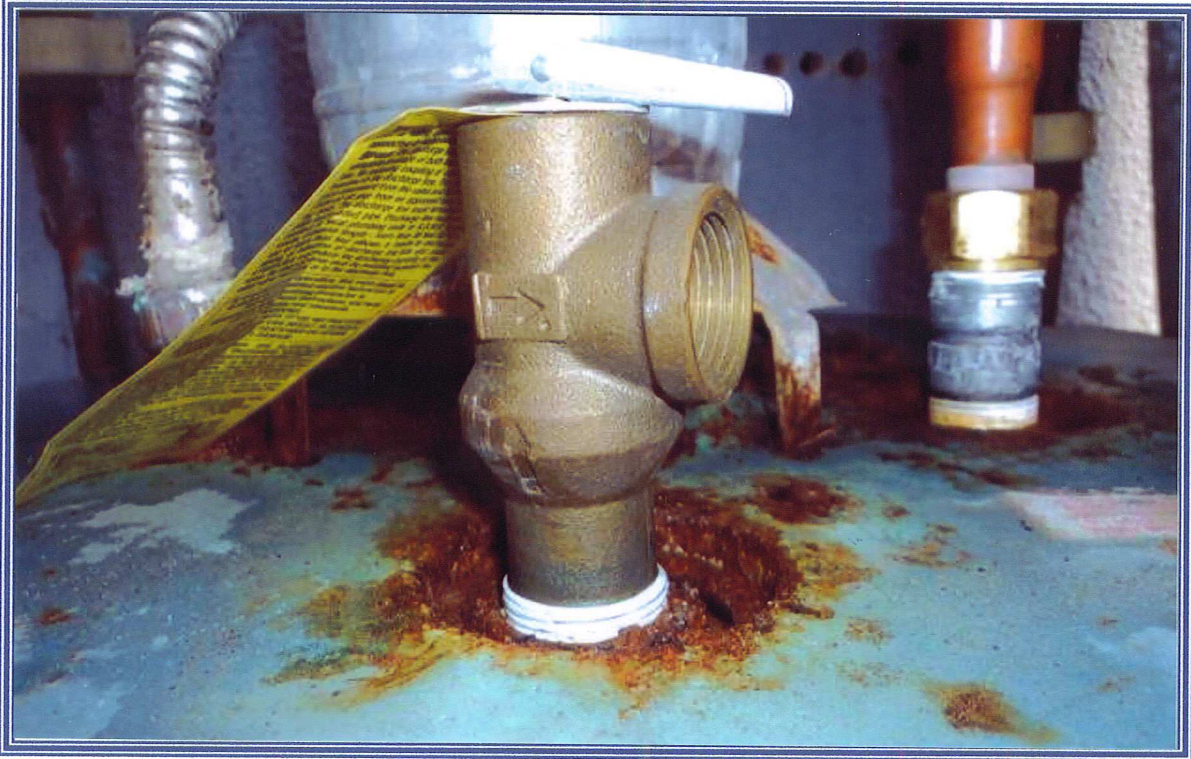
Main Plumbing:

- * Hot water tanks should have a relief valve with attached pipe leading to within 4-8 inches from the floor. If ever there was a need for a relief valve and "blow-out" pipe, this would be it.

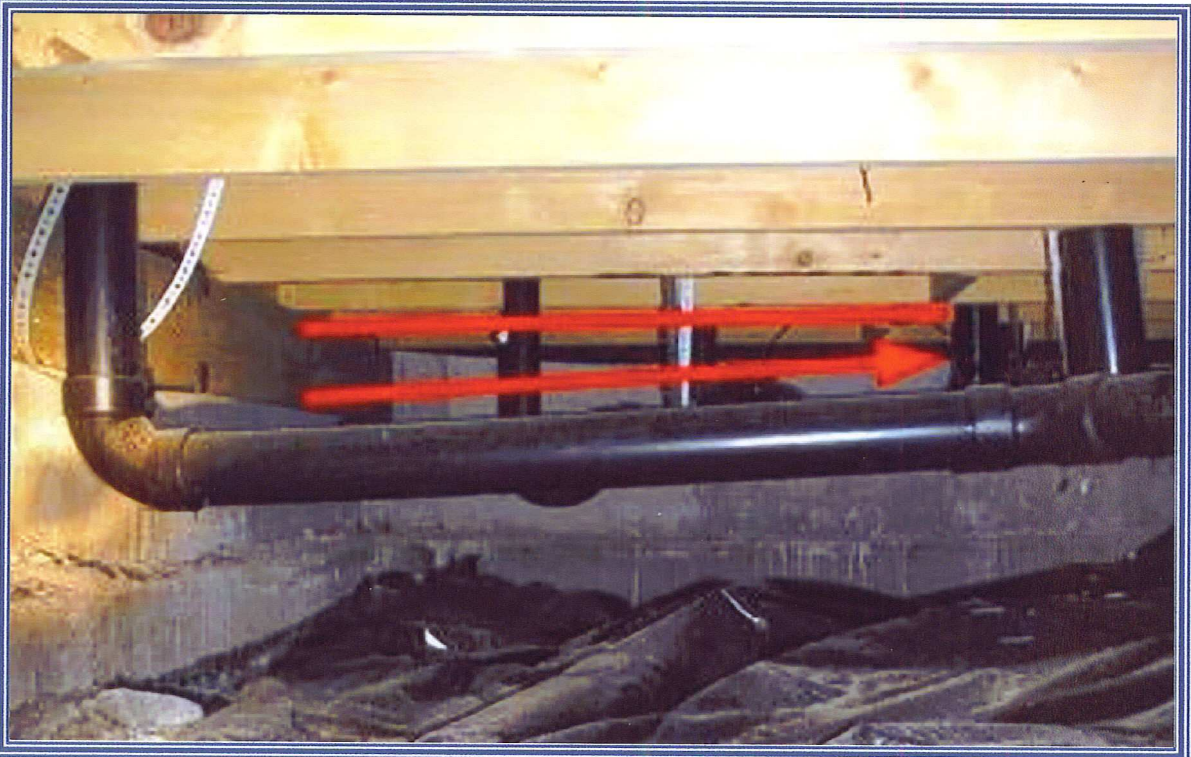
Main Plumbing:

- * You've heard the old saying... "S--t flows down hill." Well it's true even in houses. This sewage pipe is sloping about 6 inches the wrong way.

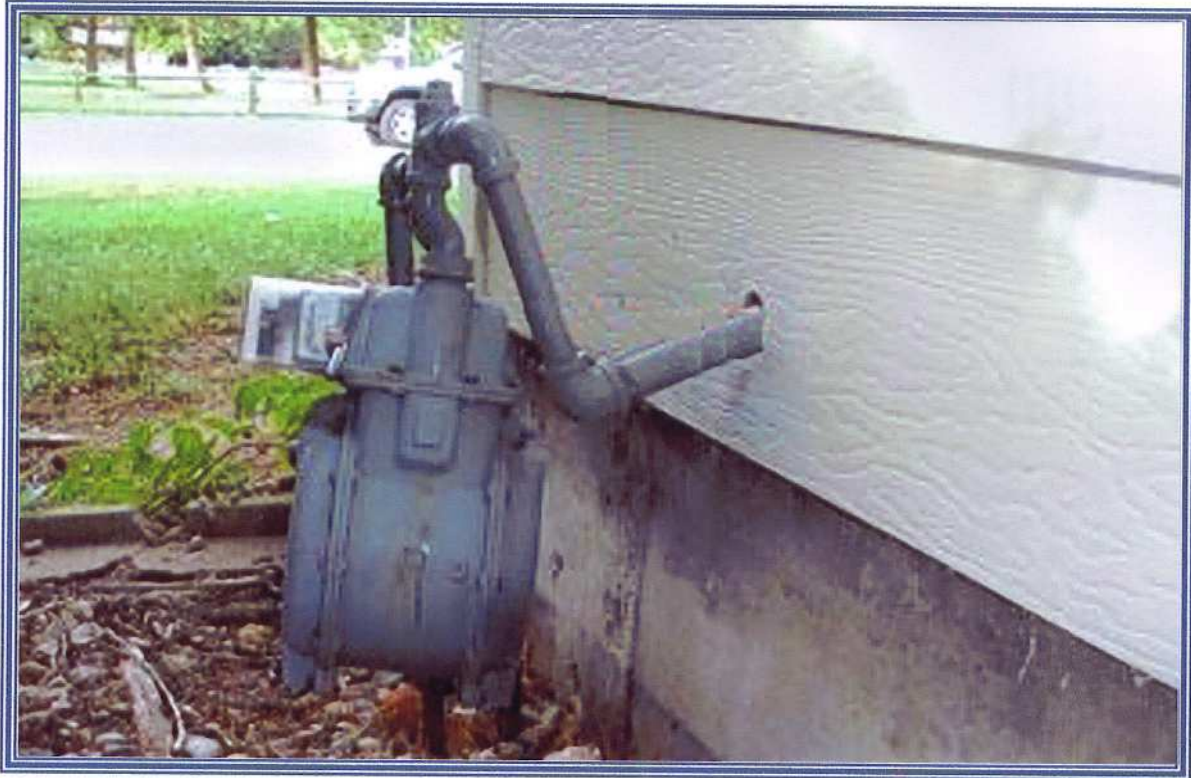
Main Heating:

- * Looks like this gas meter took a bad hit from the mower. I'm sure it's not leaking.... I hope it's not leaking.

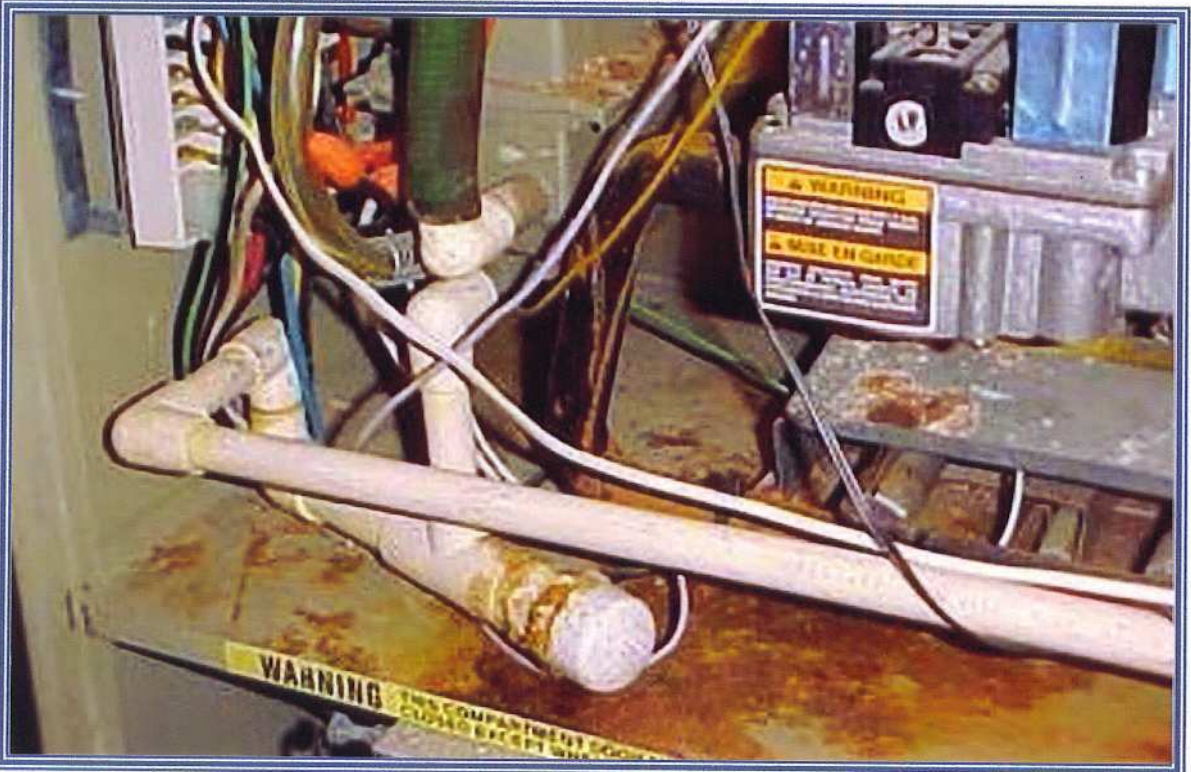
Main Heating:

- * Interestingly, this leaking air conditioning condensate line is in the furnace at the other end of the damage gas meter. Some people are just not all that into maintenance.
