***So... What kind of things does a
Home Inspector discover
anyway...?***

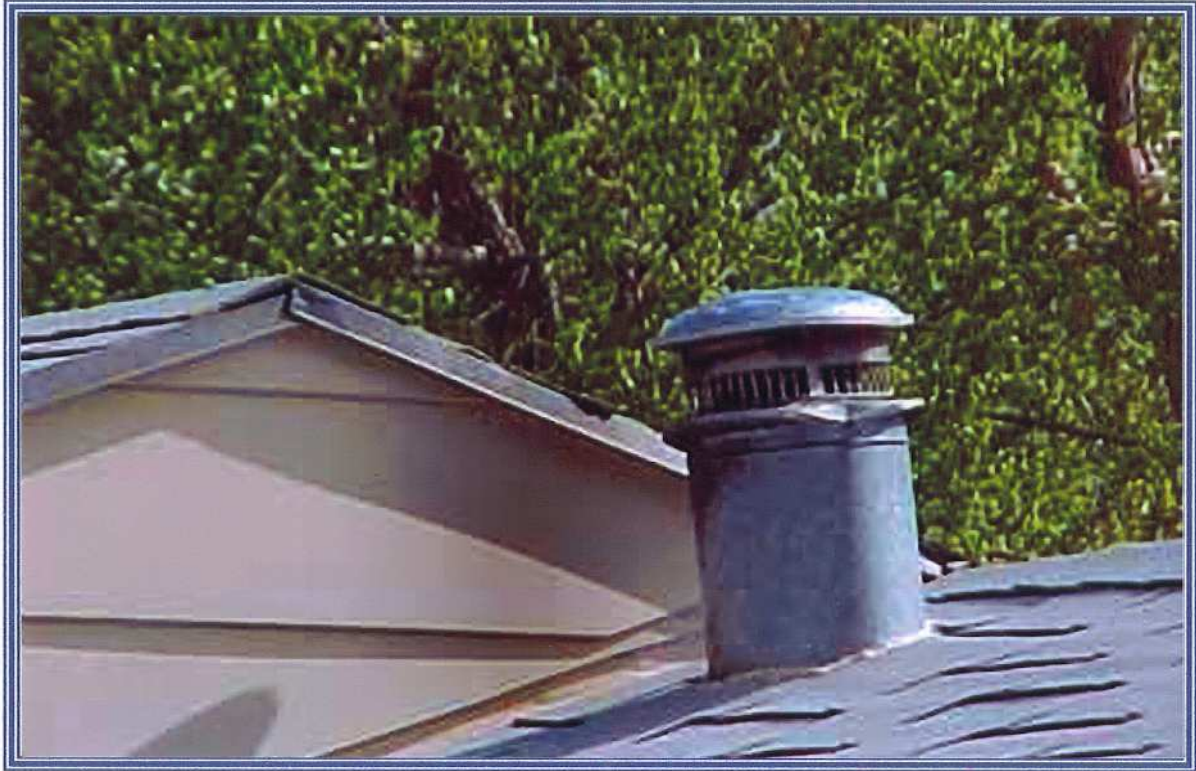
Main Heating:

- * This chimney flue is too short and could cause poor drafting issues. Also sparks could easily land on nearby roofing.

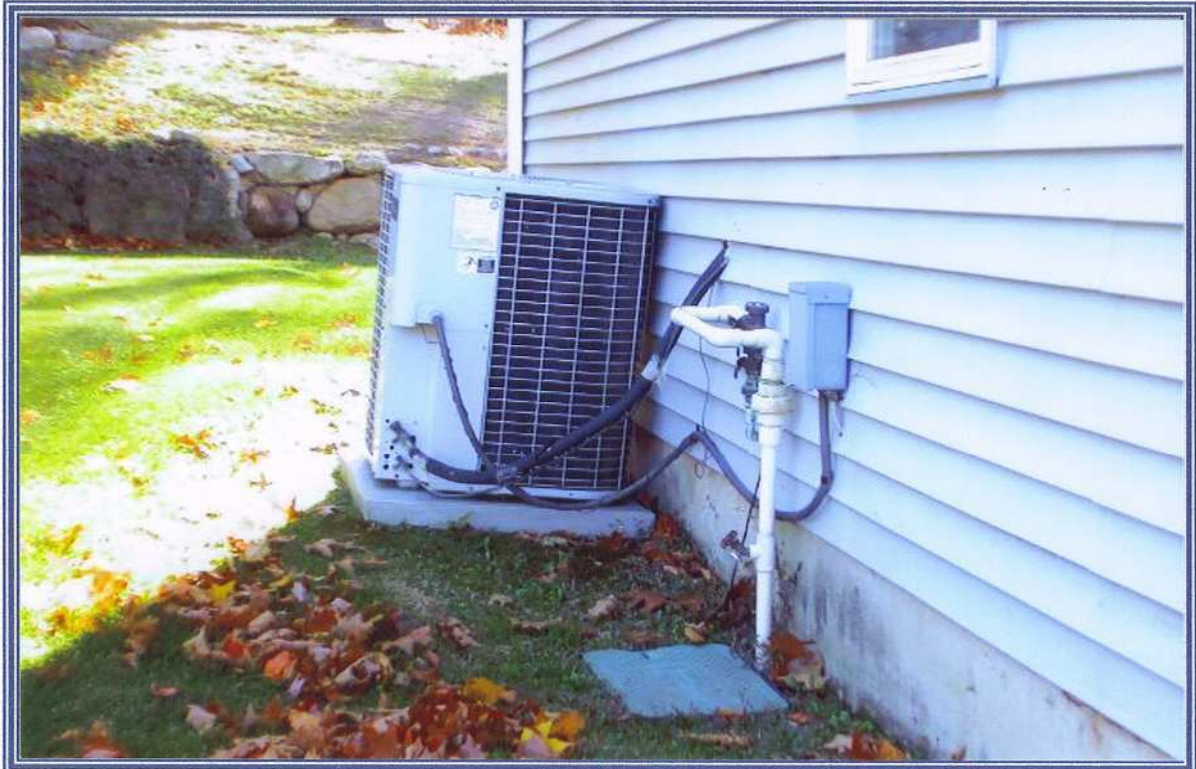
Main Heating:

- * Air conditioner condenser units should be level per manufacture specifications. Otherwise the blower motor bearings can wear prematurely.

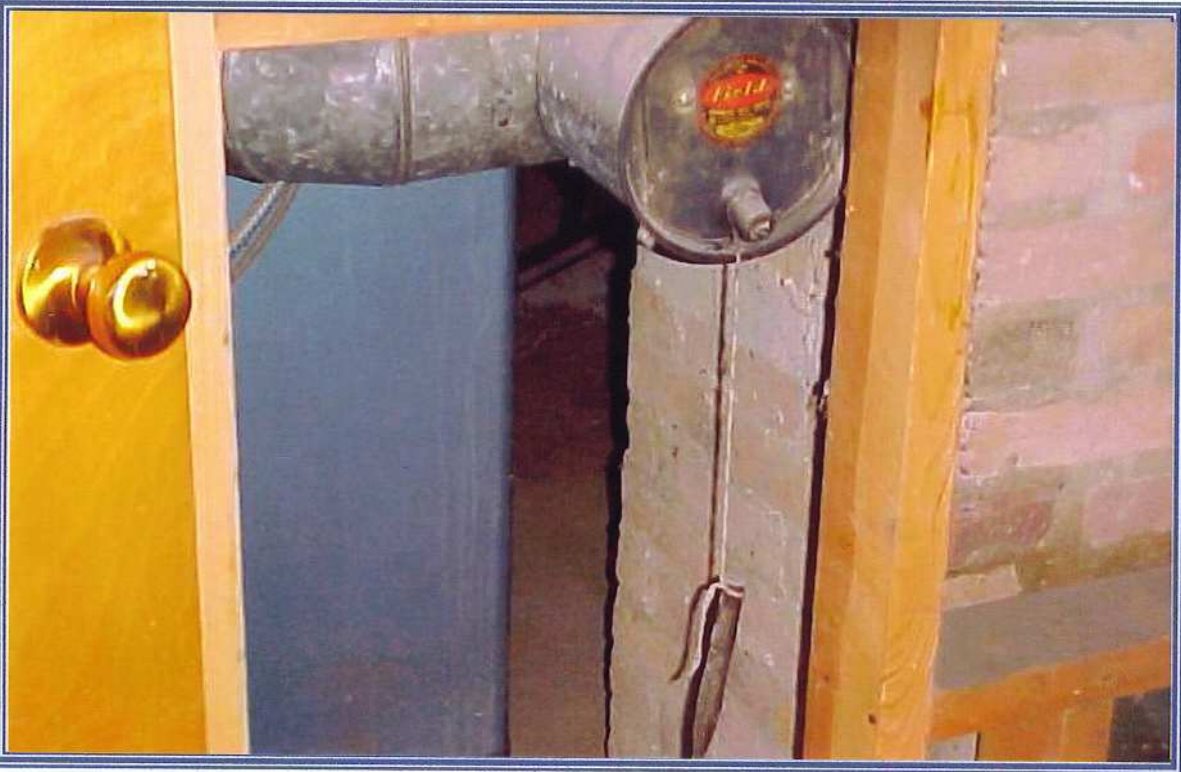
Main Heating:

- * Oil furnaces have barometric dampers for a reason – they open/close automatically to regulate flue exhaust. Something tells me this one is not so automatic.

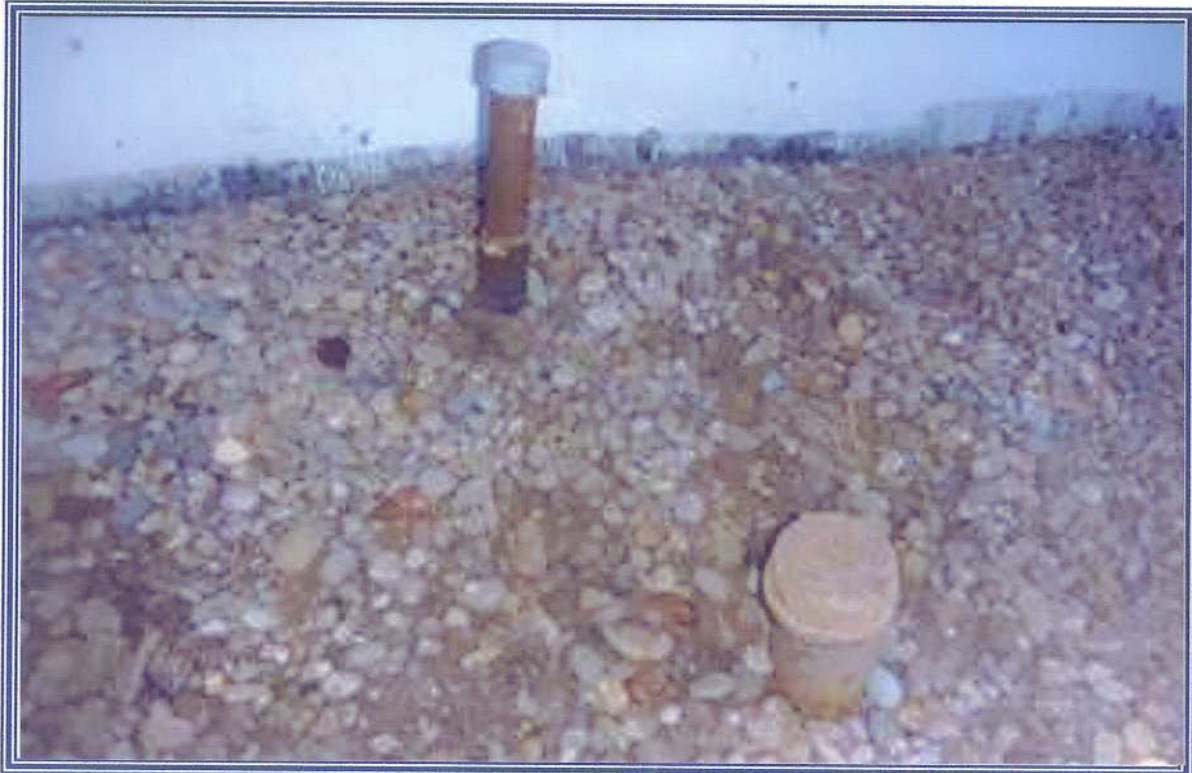
Main Heating:

- * Sometimes it's what you don't see that concerns you. This house was just converted from oil to a brand new high efficiency natural gas furnace. I wonder what they did with the old oil tank....

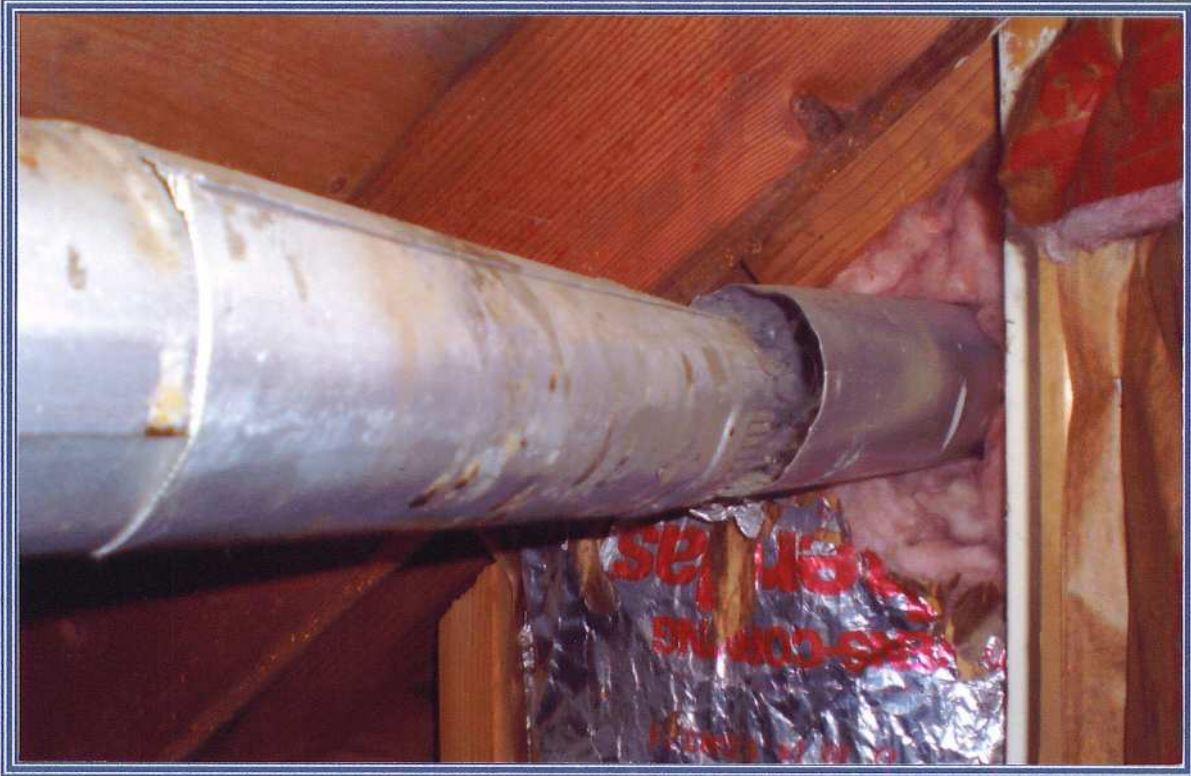
General Inspection:

- * There are so many components in a house that it would take 50-60 hours to do a proper inspection. But that would not be cost effective, so home inspectors look for the obvious and the not so obvious. Below is an unattached bathroom vent – no damage to the attic area (yet).

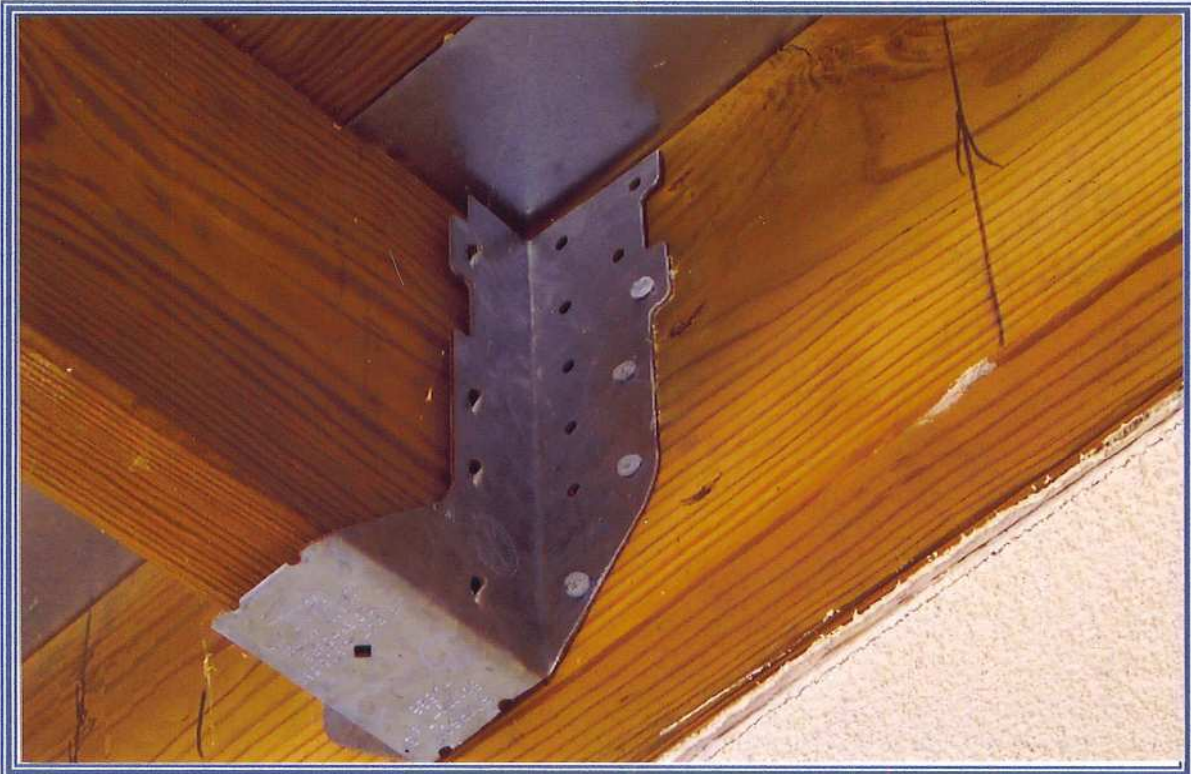
General Inspection:

- * Each nail in a joist hanger bares a certain amount of the weight load by design. With eight nails (4 on each side) out of the intended 22, this deck joist hanger will only hold 36% of its designed load.

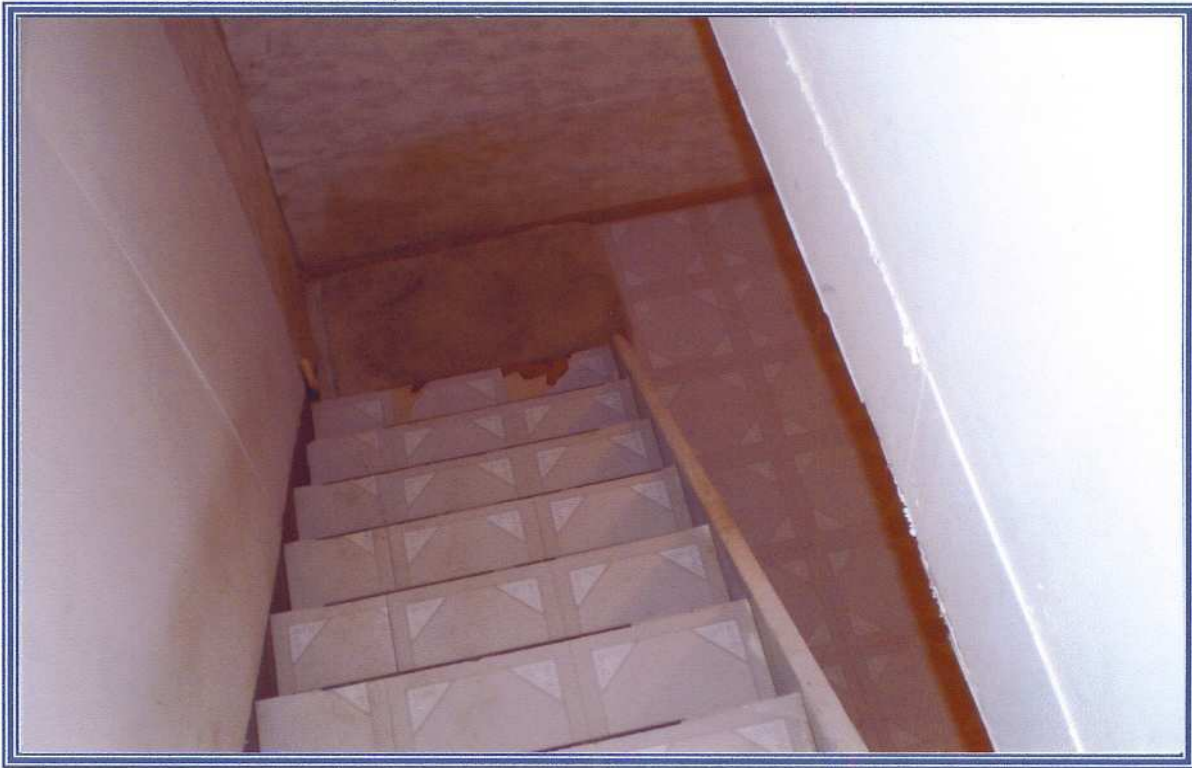
General Inspection:

- * No hand rail – no problem... Just gonna run down to the basement and grab the suitcases for our vacation. Have a nice trip..!

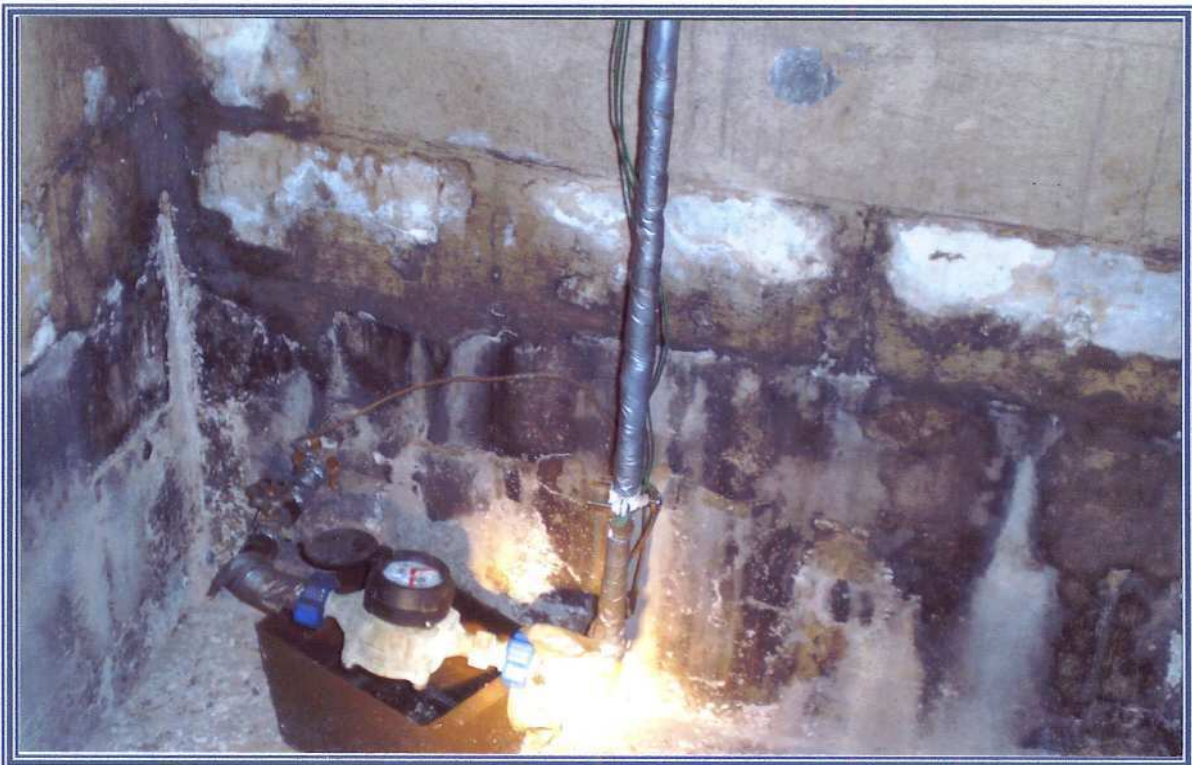
General Inspection:

- * Maybe I should turn off the water main, just in case there's a leak somewhere... Maybe not.

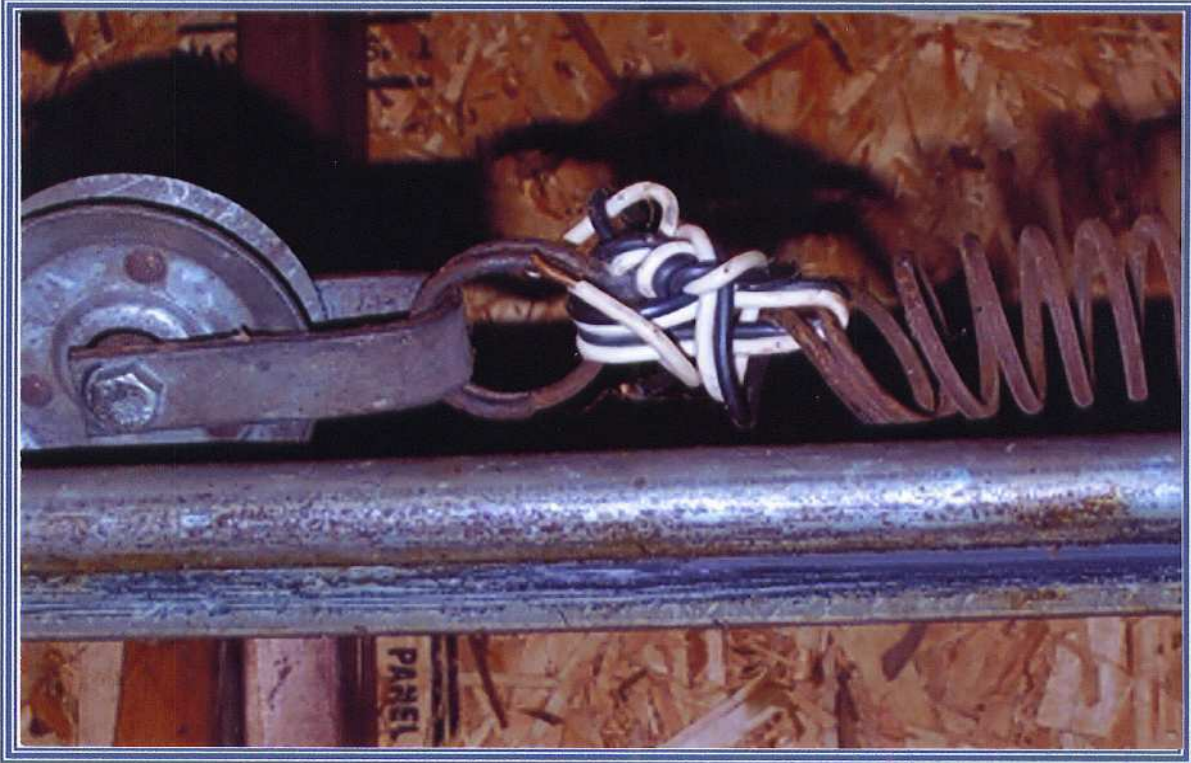
General Inspection:

* Garage door springs can be very dangerous if not installed properly or if over tightened. I wonder which would hurt more, the garage door falling on my foot or the spring hitting me in the head.

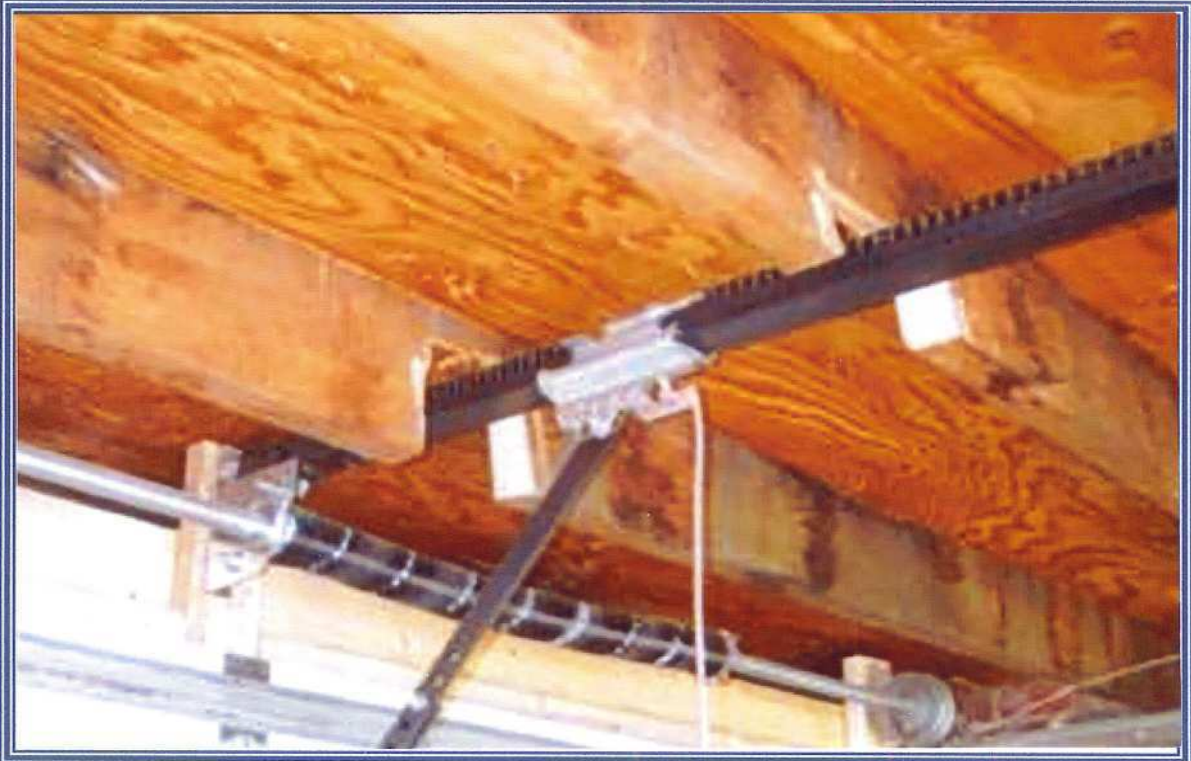
General Inspection:

* Much better – this garage door and opener were just installed by the seller. It's not a matter of if the floor above (used for storage) will give way – it's just a matter of when (total of 5 compromised floor joists).
