## **Custom Home Inspection Report**

### Mr. & Mrs Joesph W. Doe 99 House Lane ~ YourTown New York, 14655

# SiteTech Home Inspections, LLC 585-703-0369

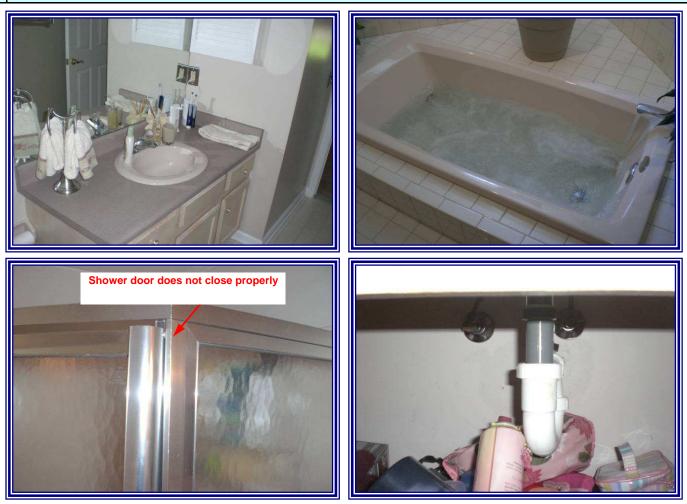
14	Acceptable	Whirlpool tub	Whirlpool tested ok - appears to be in proper condition.		
15	Acceptable	Toilet:	2-piece - fixture is functioning properly.		
16	Marginal	Shower	Shower door does not properly close and could cause water to exit shower. Suggest repair/realignment.
